8.5 Ballard Lake

An Introduction to Ballard Lake

8.5.1 Ballard Lake Water Quality

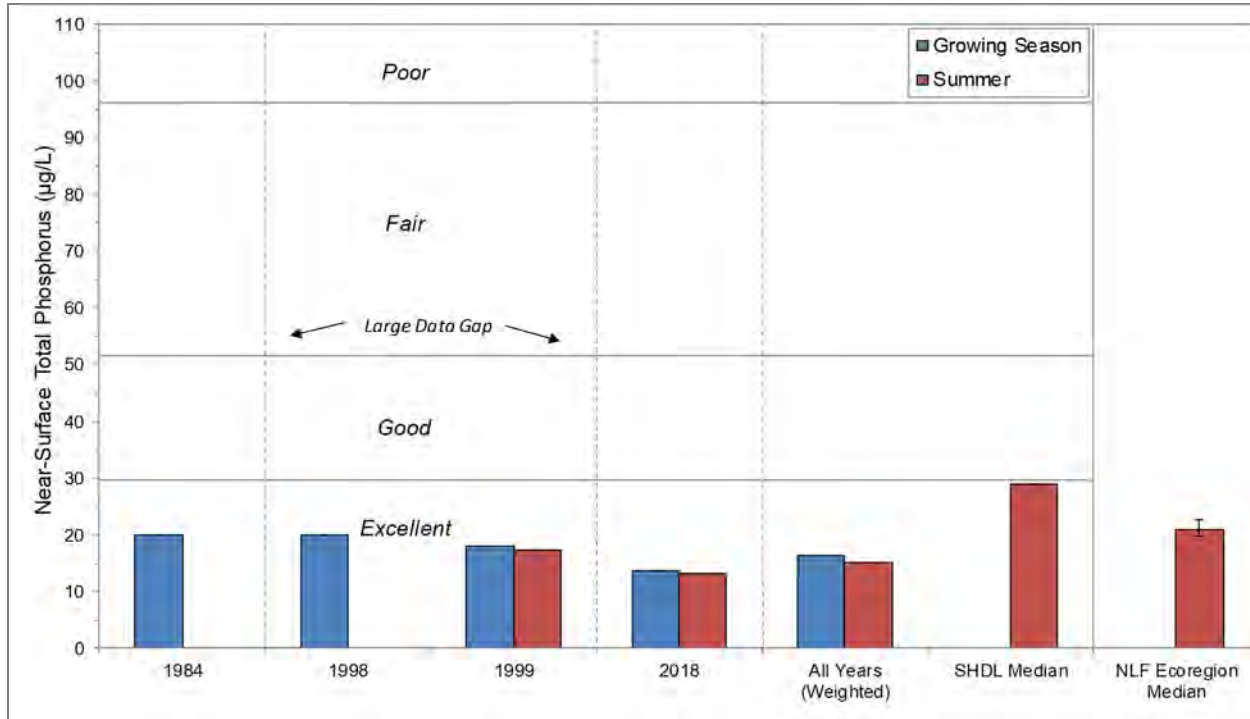
Figure 8.5.1-1. Ballard Lake, statewide shallow headwater drainage lakes, and regional total phosphorus concentrations. Mean values calculated with summer month surface sample data. Water Quality Index values adapted from WDNR PUB WT-913.

Near-surface total phosphorus data from Ballard Lake are available from 1984, 1998-1999, and 2018 (Figure 8.5.1-1). The weighted summer average total phosphorus concentration is 15.3 µg/L and falls into the *excellent* category for shallow headwater drainage lakes in Wisconsin. Ballard Lake’s summer average total phosphorus concentrations are below both the median value for shallow headwater drainage lakes in the state and the median value for all lake types in the Northern Lakes and Forests (NLF) ecoregion. Total phosphorus data were also collected in 1926-1929 by Birge and Juday (Splitt 2001). The average summer concentration during this period was

24.3 µg/L, higher than the more recent measured average of 15.3 µg/L. It's important to note that phosphorus concentrations can be variable from year to year and over longer periods of time due to changes in precipitation. Higher concentrations measured in 1926-1929 can be considered a snap-shot of this period, and indicate that phosphorus concentrations likely fluctuate in Ballard Lake over longer periods of time.

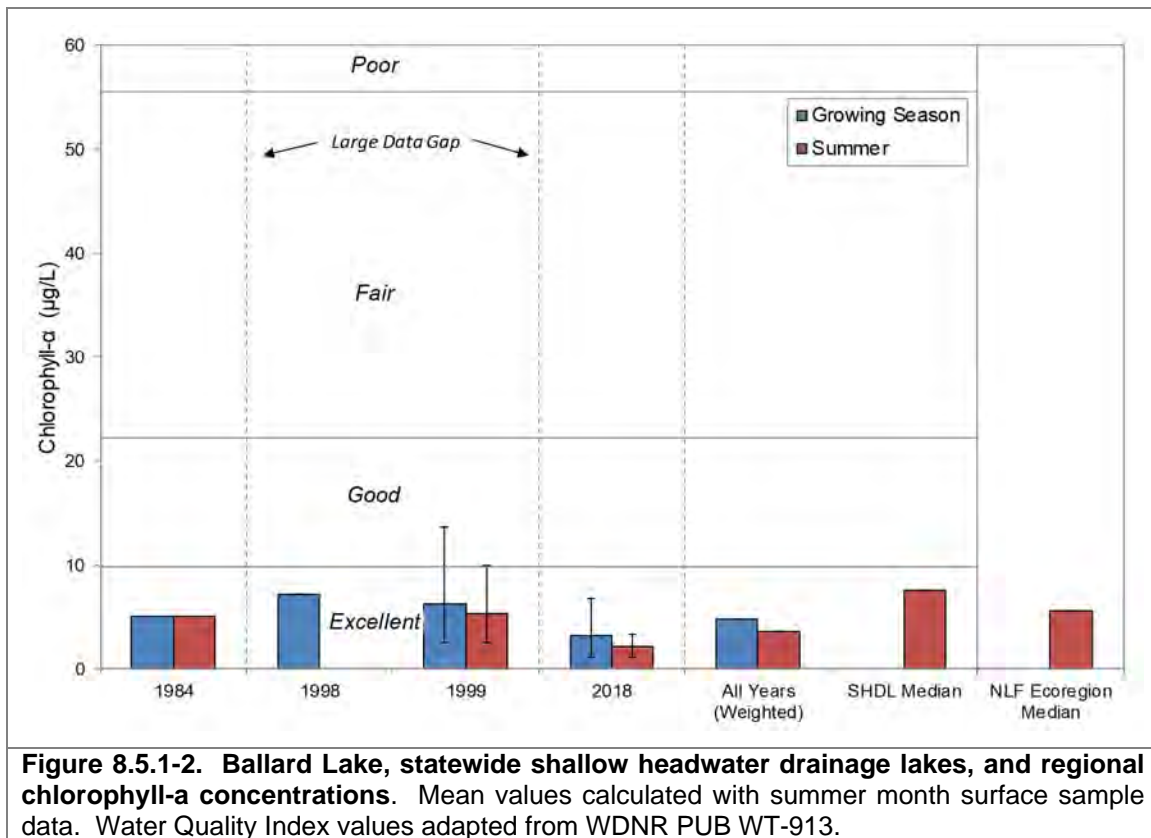
Chlorophyll-*a* data are available from Ballard Lake from 1984, 1998-1999, and 2018 (Figure 8.5.1-2). Average summer chlorophyll-*a* concentrations had a small range from 2.1 µg/L in 2018 to 5.4 µg/L in 1999. Ballard Lake's summer average chlorophyll-*a* concentration is 3.6 µg/L and falls into the *excellent* category for shallow headwater drainage lakes in Wisconsin. Ballard Lake's summer average chlorophyll-*a* concentrations are below both the median value for shallow headwater drainage lakes in the state as well as the median value for all lake types in the NLF ecoregion.

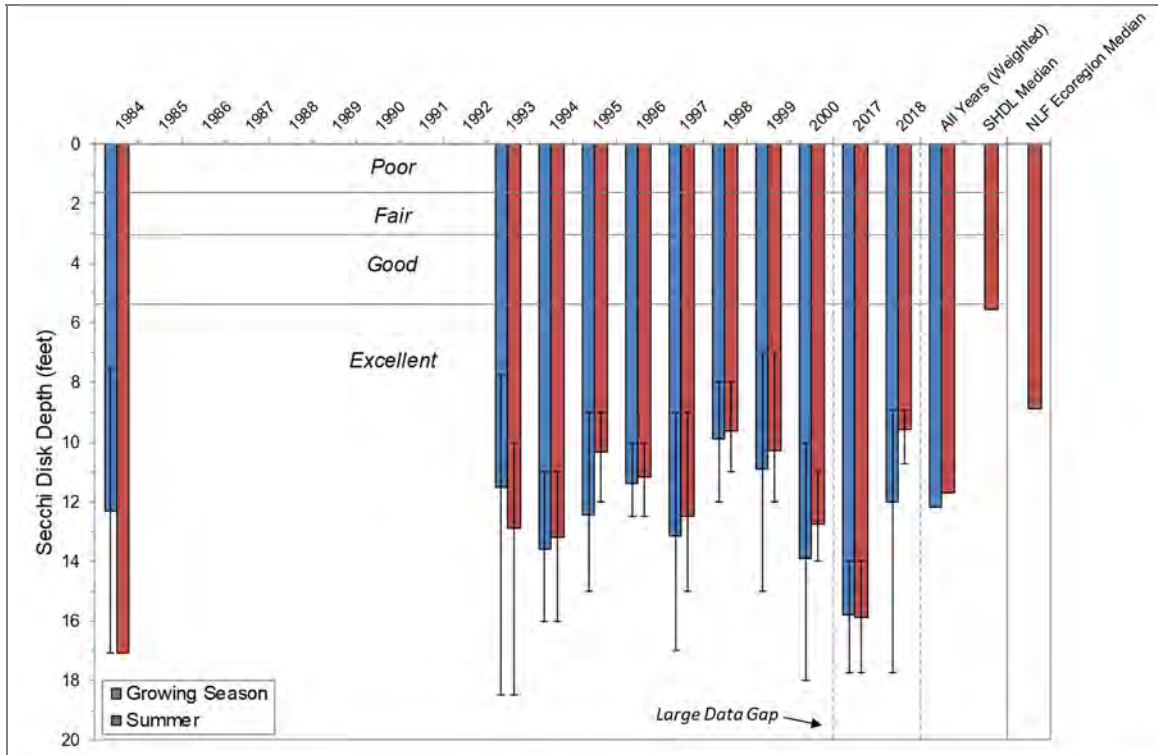
Figure 8.5.1-3. Ballard Lake, statewide shallow headwater drainage lakes, and regional Secchi disk clarity values. Mean values calculated with summer month surface sample data. Water Quality Index values adapted from WDNR PUB WT-913.

Secchi disk transparency data are available from Ballard Lake for 1984 and from 1993-2018 (Figure 8.5.1-3). The weighted summer average Secchi disk depth is 11.7 feet and falls into the *excellent* category for shallow headwater drainage lakes in Wisconsin. Ballard Lake's weighted summer average Secchi disk depth is approximately 6.1 feet deeper than the median value for shallow headwater drainage lakes in the state and approximately 2.8 feet deeper than the median value for all lake types in the NLF ecoregion. Secchi disk depths are also available from 1927-1930 from Birge and Juday (Splitt 2001). The average Secchi disk depth from this period was 7.4 feet. A Secchi disk depth measurement of 8.5 feet was also collected in 1960 (Black et al. 1960). These values were slightly lower than measurements made more recently.

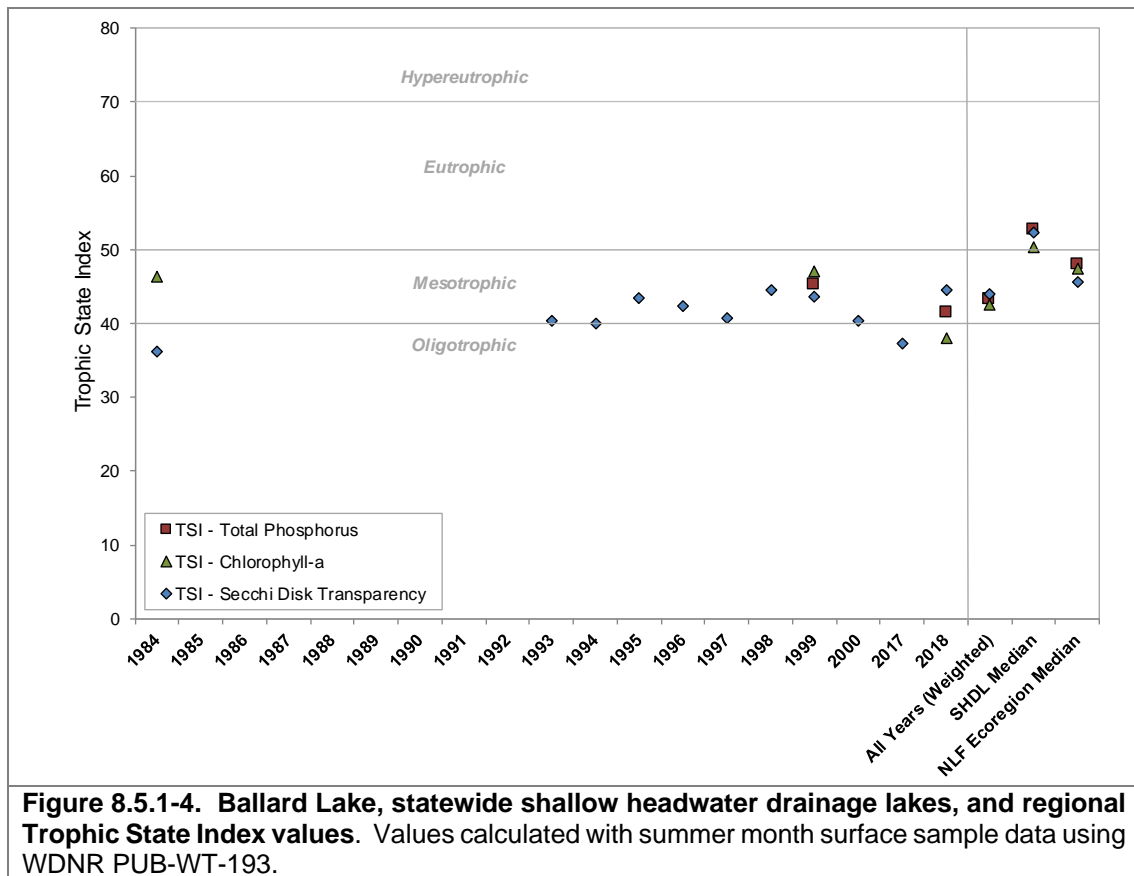
Figure 8.5.1-4 contains the Trophic State Index (TSI) values for Ballard Lake. These TSI values are calculated using summer near-surface total phosphorus, chlorophyll-*a*, and Secchi disk transparency data collected as part of this project along with available historical data. In general, the best values to use in assessing a lake’s trophic state are chlorophyll-*a* and total phosphorus, as water clarity can be influenced by factors other than phytoplankton such as dissolved organic compounds. The closer the calculated TSI values for these three parameters are to one another indicates a higher degree of correlation.

The weighted TSI values for total phosphorus and chlorophyll-*a* (and Secchi disk transparency) in Ballard Lake indicate the lake is at present in a mesotrophic state. Ballard Lake’s productivity is lower when compared to other shallow headwater drainage lakes in Wisconsin and all lake types within the NLF ecoregion.

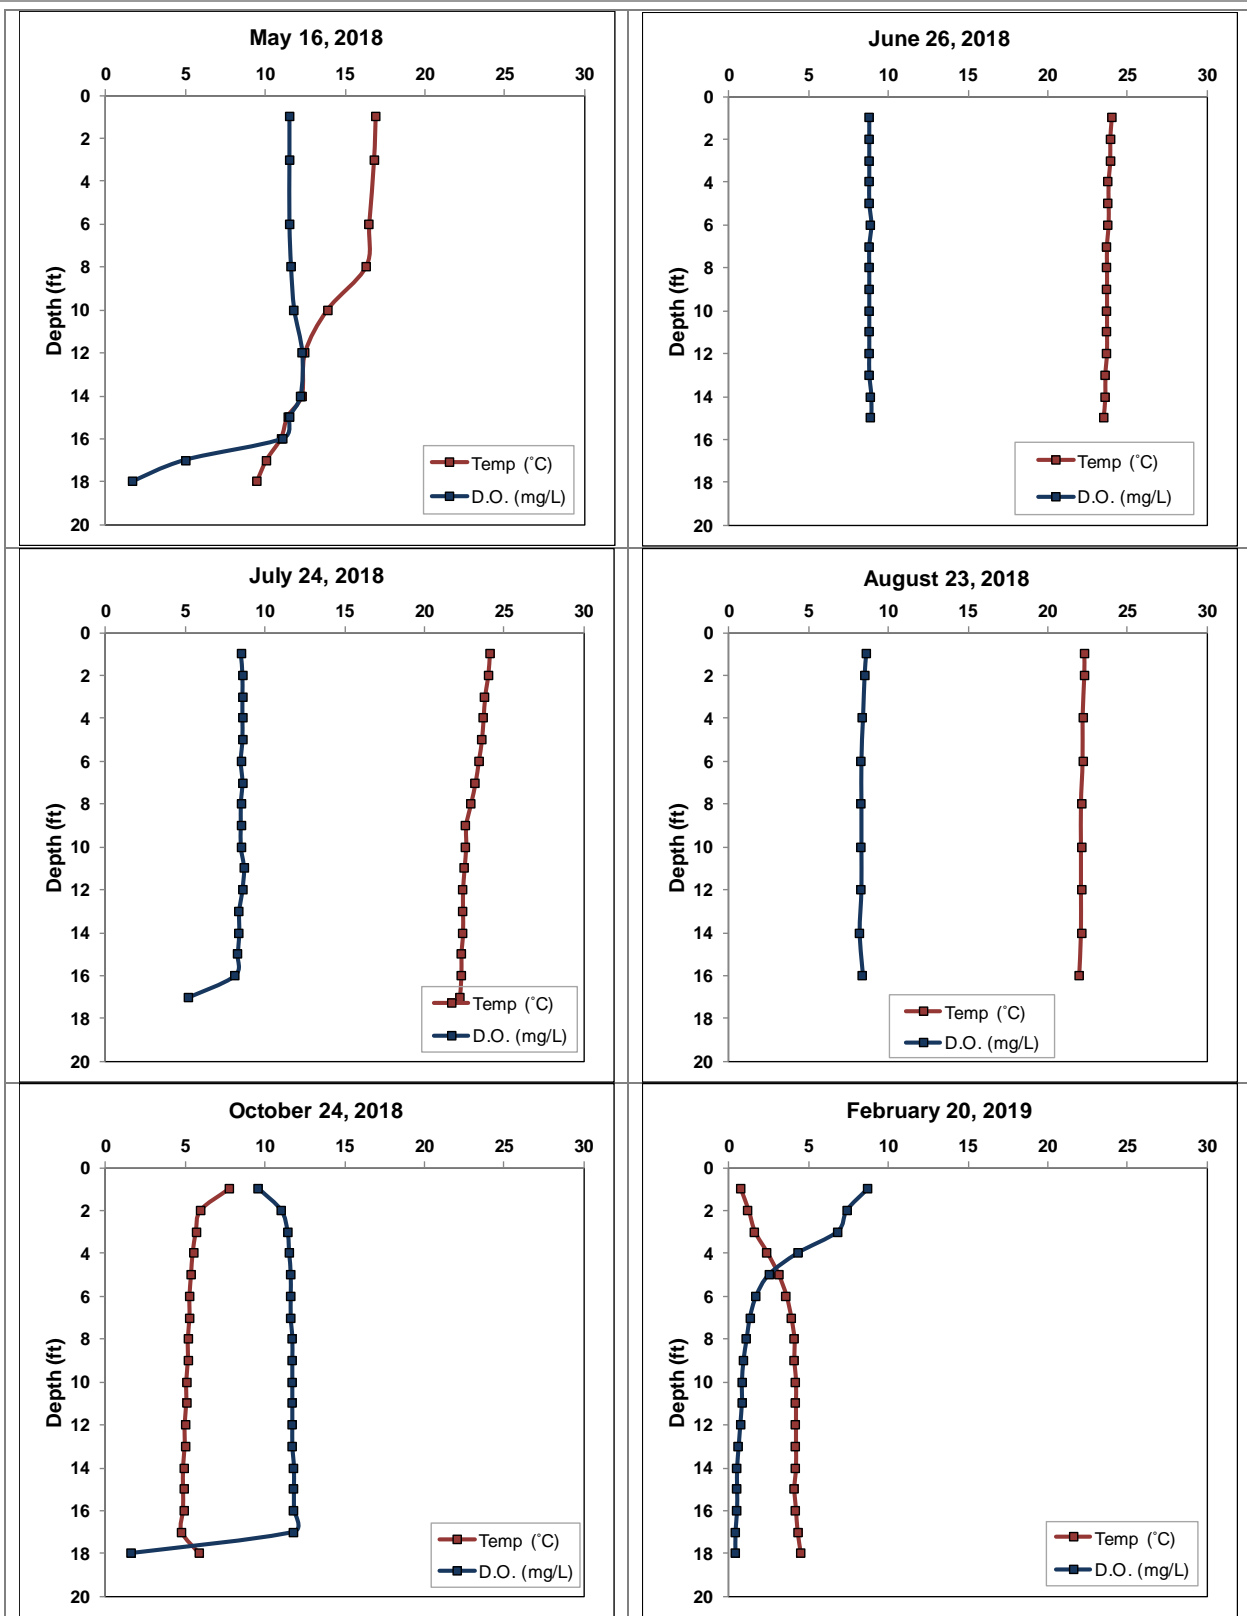
Figure 8.5.1-5. Ballard Lake 2018-2019 dissolved oxygen and temperature profiles.

Dissolved oxygen and temperature were measured during water quality sampling visits to Ballard Lake by Onterra staff. Profiles depicting these data are displayed in Figure 8.5.1-5.

Ballard Lake is *polymictic* [lakes that are too shallow to thermally stratify and can mix throughout the growing season] and the temperature at the bottom was over 22°C in July 2018, indicating that the lake frequently mixes (Figure 8.5.1-5). Because of its polymictic nature, there is sufficient oxygen throughout the water column during the summer to support a lake-wide fishery. The profile from February 20, 2019 shows that there is sufficient oxygen in the upper waters to prevent a winter fishkill.

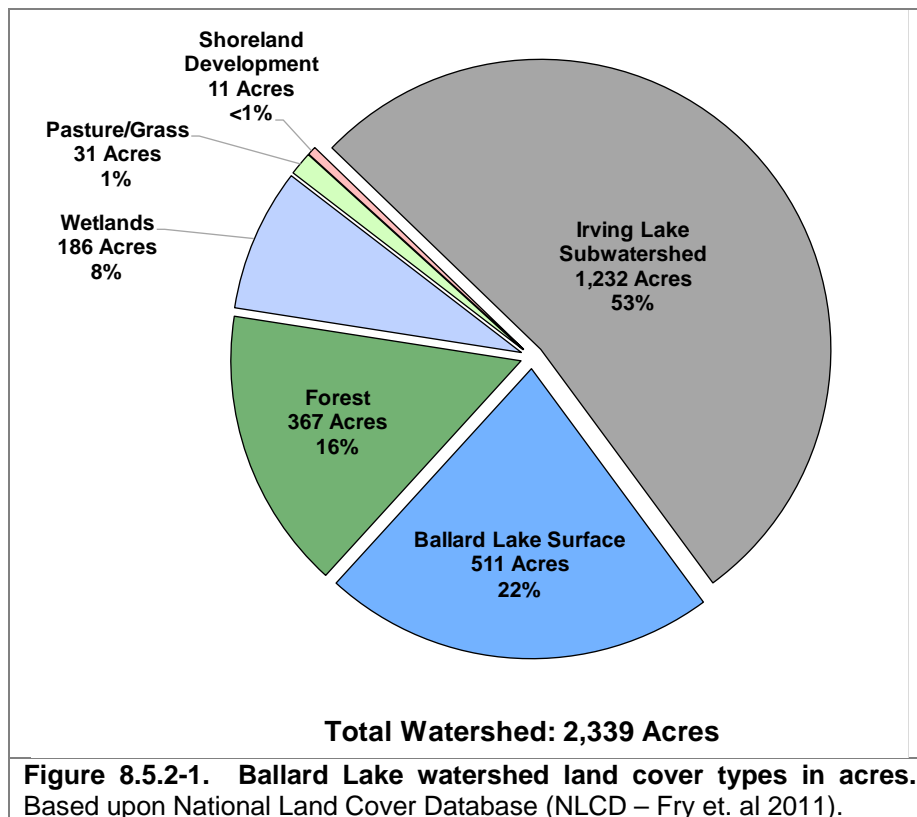
The largest part of the lake's watershed is the Irving Lake watershed which is immediately upstream of Ballard Lake. Of the remaining part of the watershed, 22% of Ballard Lake's watershed is the lake's surface, 16% is forest, 8% is wetlands, 1% is pasture/grass, and <1% is shoreland development (Figure 8.5.2-1).

Ballard Lake's watershed encompasses an area of approximately 2,339 acres, yielding a small watershed to lake area ratio of 4:1 (Figure 8.5.2-1, Ballard Lake – Map 2). According to WiLMS modeling, the lake's water residence time is 2.6 years or the lake water is replaced approximately 0.4 times per year (flushing rate).

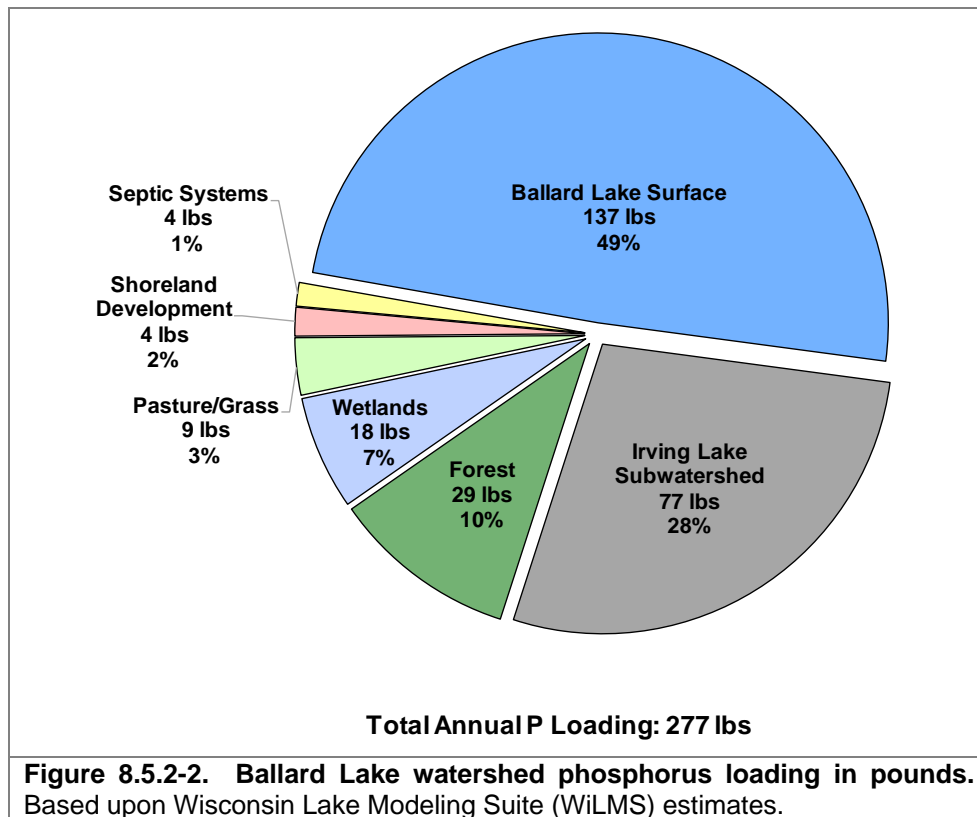
Of the estimated 277 pounds of phosphorus being delivered annually to Ballard Lake, 137 pounds (49%) is estimated to originate from direct atmospheric deposition into the lake, 77 pounds (28%) from Irving Lake, 29 pounds (10%) from forest, 18 pounds (7%) from wetlands, 9 pounds (3%) from pasture/grass, 4 pounds (2%) from shoreland development and 4 pounds (1%) from riparian septic systems (Figure 8.5.2-2).

Using the land cover data described above, WiLMS was utilized to estimate the annual potential phosphorus load from Ballard Lake's watershed. It was estimated that approximately 277 pounds of phosphorus is delivered to Ballard Lake from its watershed on an annual basis (Figure 8.5.2-2).

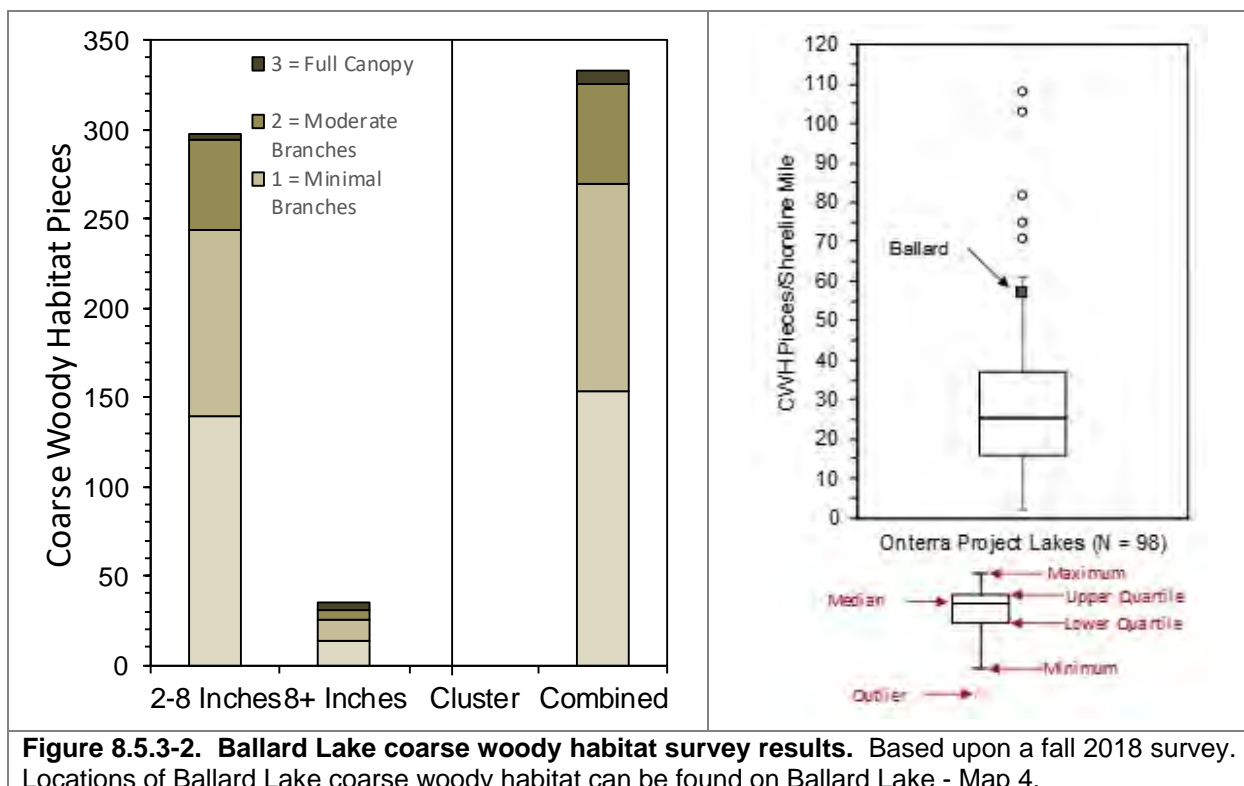
During this survey, 333 total pieces of coarse woody habitat were observed along 5.9 miles of shoreline (Ballard Lake - Map 4), which gives Ballard Lake a coarse woody habitat to shoreline mile ratio of 57:1 (Figure 8.5.3-2). Only instances where emergent coarse woody habitat extended from shore into the water were recorded during the survey. Of the 333 total pieces of coarse woody habitat observed during the survey, 298 pieces were 2-8 inches in diameters, 35 were 8 inches in diameter or greater, and no clusters of pieces of coarse woody habitat were found.

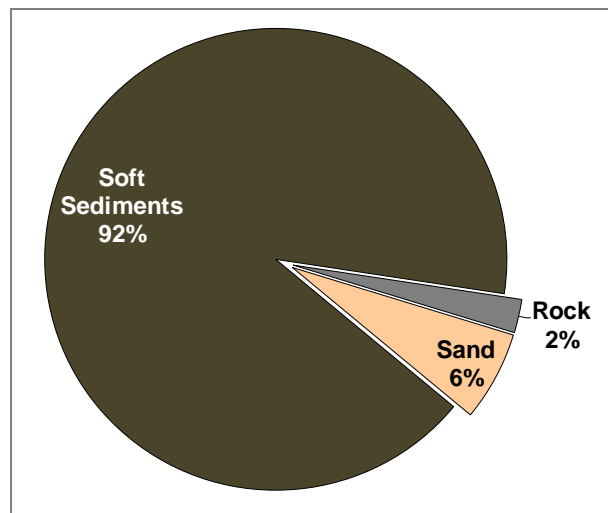
Figure 8.5.4-1. Ballard Lake 2018 proportion of substrate types. Created from data collected during the 2018 whole-lake point-intercept survey (N = 556).

As discussed in the primer section, sediment data were collected at each sampling location within the littoral zone during the point-intercept survey. Approximately 92% of the point-intercept locations within littoral areas contained fine, organic sediments (muck), 6% contained sand, and 2% contained rock (Figure 8.5.4-1). The shallow areas on the eastern shoreline of Ballard Lake contained more sand than any other areas around the lake (Ballard Lake - Map). Like terrestrial plants, different aquatic plant species are adapted to grow in certain substrate types; some species are only found growing in mucky substrates, others only in sandy areas, and some can be found growing in either. Lakes that have varying substrate types generally support a higher number of plant species because of the different habitat types that are available.

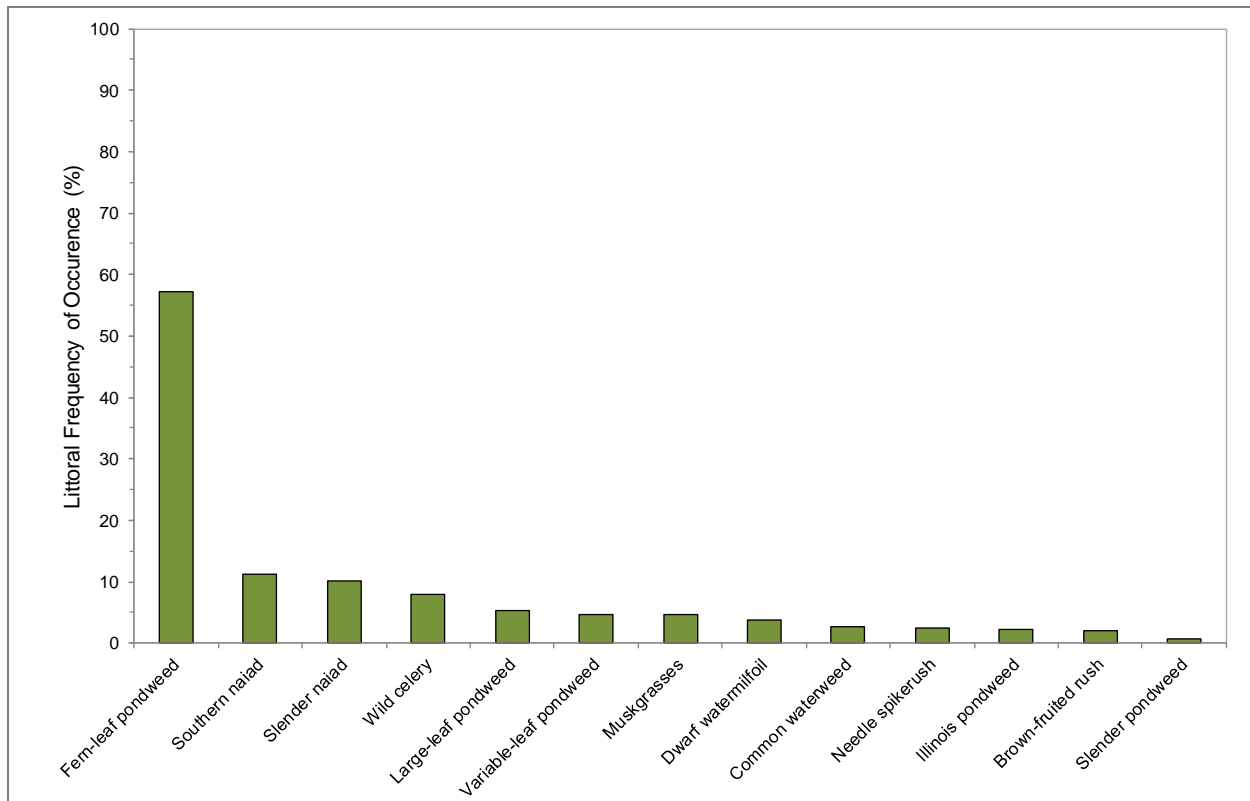
Figure 8.5.4-3. Ballard Lake 2018 littoral frequency of occurrence of aquatic plant species. Created using data from 2018 whole-lake point-intercept survey.

Of the 40 native aquatic plant species located in Ballard Lake in 2018, 26 were encountered directly on the rake during the whole-lake point-intercept survey (Figure 8.5.4-3). The remaining 14 plants were located incidentally, meaning they were observed by Onterra ecologists while on the lake but they were not directly sampled on the rake at any of the point-intercept sampling locations. Incidental species typically include emergent and floating-leaf species that are often found growing on the fringes of the lake and submersed species that are relatively rare within the plant community. Of the 26 species directly sampled with the rake during the point-intercept survey, fern-leaf pondweed, southern naiad, slender naiad, and wild celery were the four-most frequently encountered plants, respectively (Figure 8.5.4-3).

Fern-leaf pondweed was the most abundant plant in Ballard Lake in 2018 with a littoral occurrence of 57% (Figure 8.5.4-3). As its name suggests, has the appearance of a fern's leaf and is a common pondweed found in lakes in northern Wisconsin. This plant generally grows in dense beds which creep along the bottom of the lake, where they provide excellent structural habitat for aquatic invertebrates and fish.

Southern naiad, the second most abundant aquatic plant in Ballard Lake in 2018 with a littoral occurrence of 11% (Figure 8.5.4-3). Southern naiad can dislodge and form surface mats that interfere with navigation, recreation, and aesthetics. Often the plants are not growing in place, but rather have uprooted and aggregated on taller vegetation.

Slender naiad, the third most abundant aquatic plant in Ballard Lake in 2018 with a littoral occurrence of 10% (Figure 8.5.4-3), is one of three native naiads that can be found in Wisconsin. Being an annual, it produces numerous seeds on an annual basis and is considered to be one of the most important food sources for a number of migratory waterfowl species (Borman et al. 1997). In addition, slender naiad's small, condensed network of leaves provide excellent habitat for aquatic invertebrates.

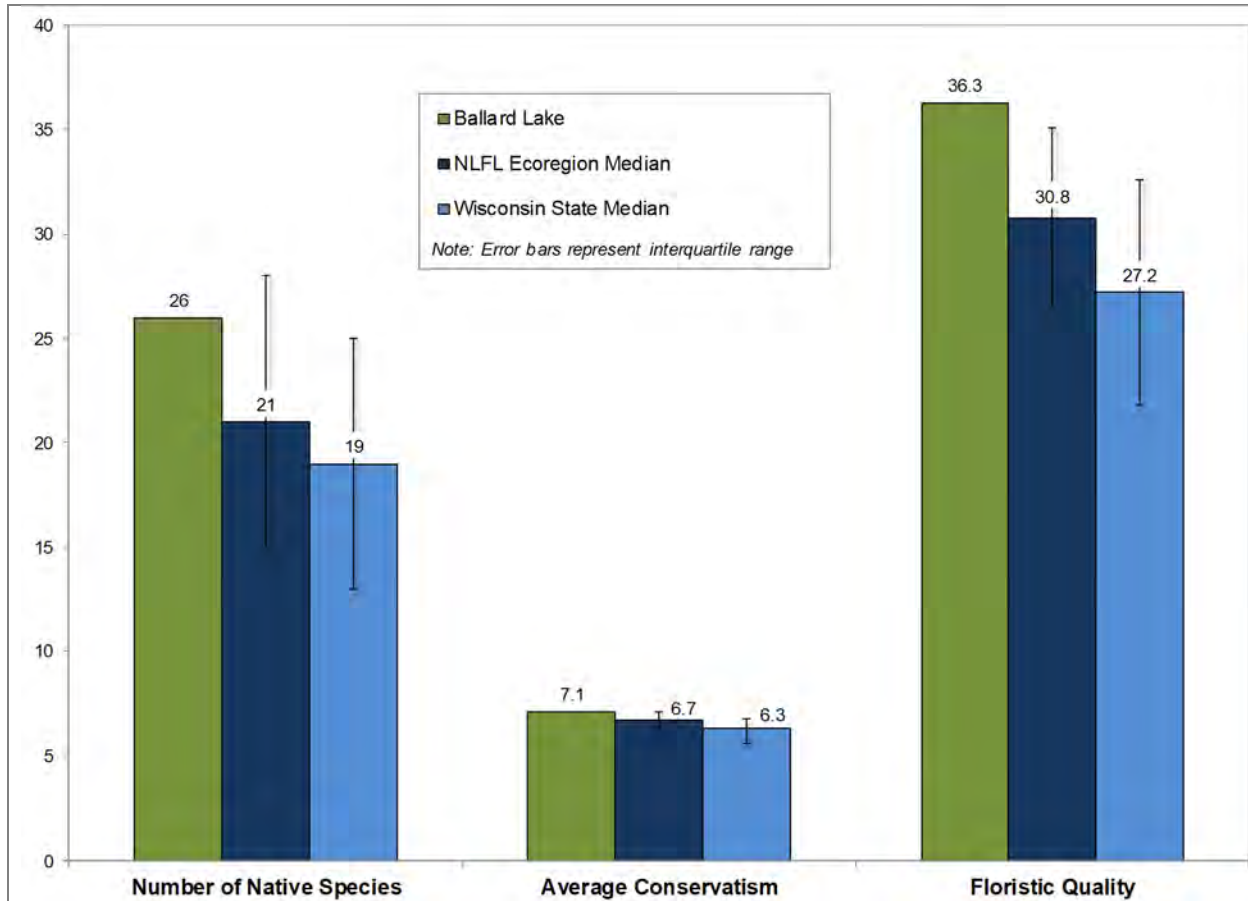
Figure 8.5.4-4. Ballard Lake Floristic Quality Assessment. Created using data from Onterra 2018 whole-lake point-intercept survey. Analysis follows Nichols (1999).

Figure 8.5.4-4 compares 2018 FQI components of Ballard Lake to median values of lakes within the Northern Lakes and Forests (NLF) ecoregion and lakes throughout Wisconsin. The number of native aquatic plant species encountered on the rake, or native species richness, was 26 for the 2018 survey. Ballard Lake’s species richness is above the median value for lakes within the ecoregion and the state.

Ballard Lake's average conservatism in 2018 was 7.1 (Figure 8.5.4-4). Ballard Lake's average conservatism is slightly above the median value for lakes in the ecoregion and above the median for lakes throughout Wisconsin, which indicates Ballard Lake's aquatic plant community contains a higher number of aquatic plants that are considered to be sensitive to environmental degradation and require high-quality habitats. Given Ballard Lake's high native species richness and conservatism values from 2018, Ballard Lake therefore has a high Floristic Quality Index value of 36.3. This FQI value is above the median for lakes in the ecoregion and well above the median value for the state, and indicates that Ballard Lake's aquatic plant community is of higher quality than the majority of lakes throughout Wisconsin.

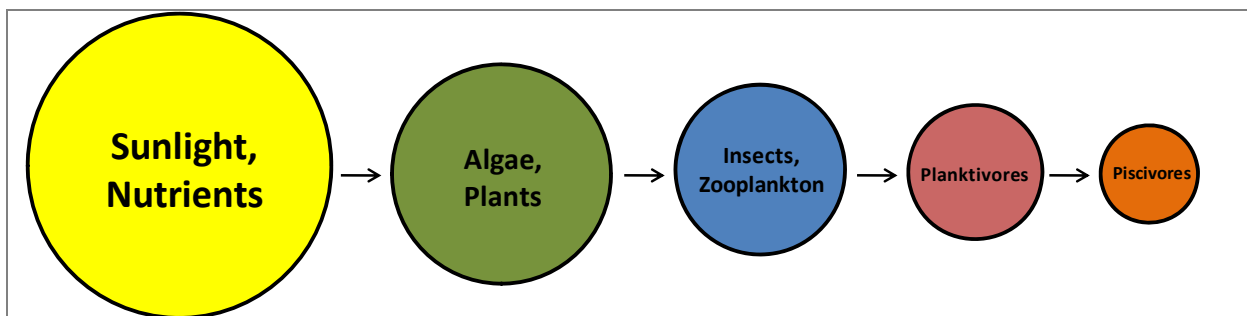
Figure 8.5.6-1. Aquatic food chain. Adapted from Carpenter et. al 1985.

A concept called energy flow describes how the biomass of piscivores is determined within a lake. Because algae and plant matter are generally small in energy content, it takes an incredible amount of this food type to support a sufficient biomass of zooplankton and insects. In turn, it takes a large biomass of zooplankton and insects to support planktivorous fish species. And finally, there must be a large planktivorous fish community to support a modest piscivorous fish community. Studies have shown that in natural ecosystems, it is largely the amount of primary productivity (algae and plant matter) that drives the rest of the producers and consumers in the aquatic food chain. This relationship is illustrated in Figure 8.5.6-1.

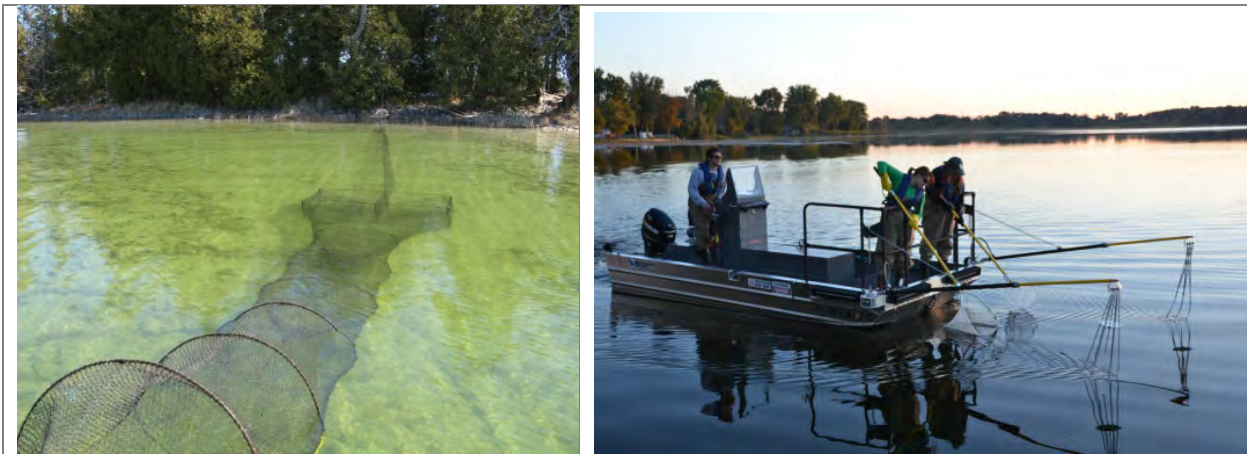
Photograph 8.5.6-1. Fyke net positioned in the littoral zone of a Wisconsin Lake (left) and an electroshocking boat (right).

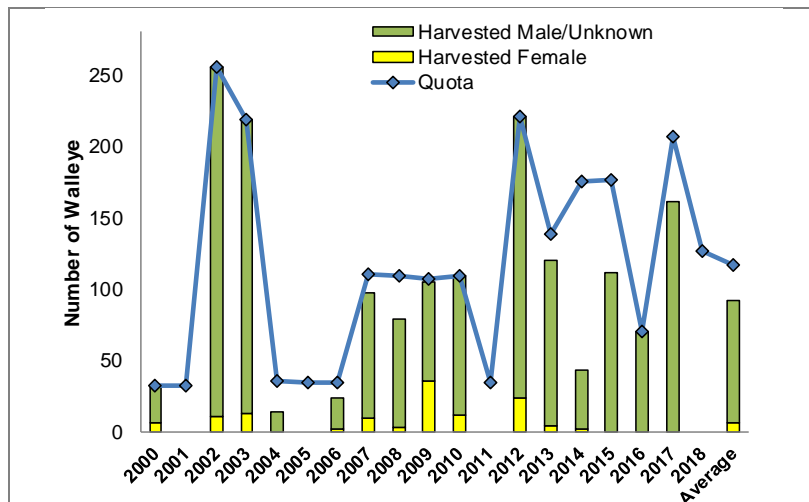
Figure 8.5.6-6. Ballard Lake walleye spear harvest data. (GLIFWC 2000-2018).

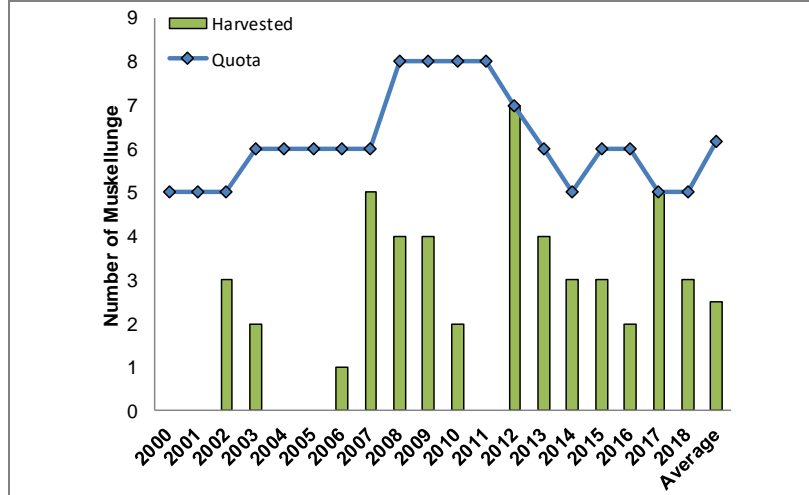
Figure 8.5.6-7. Ballard Lake muskellunge spear harvest data. (GLIFWC 2000-2018).

Muskellunge open water spear harvest records are provided in Figure 8.5.6-7 from 2000 to 2018. As many as 8 muskellunge have been harvested from the lake in the past (2008 to 2011), however the average harvest is 6 fish in a given year. Spear harvesters on average have taken 42% of the declared quota.

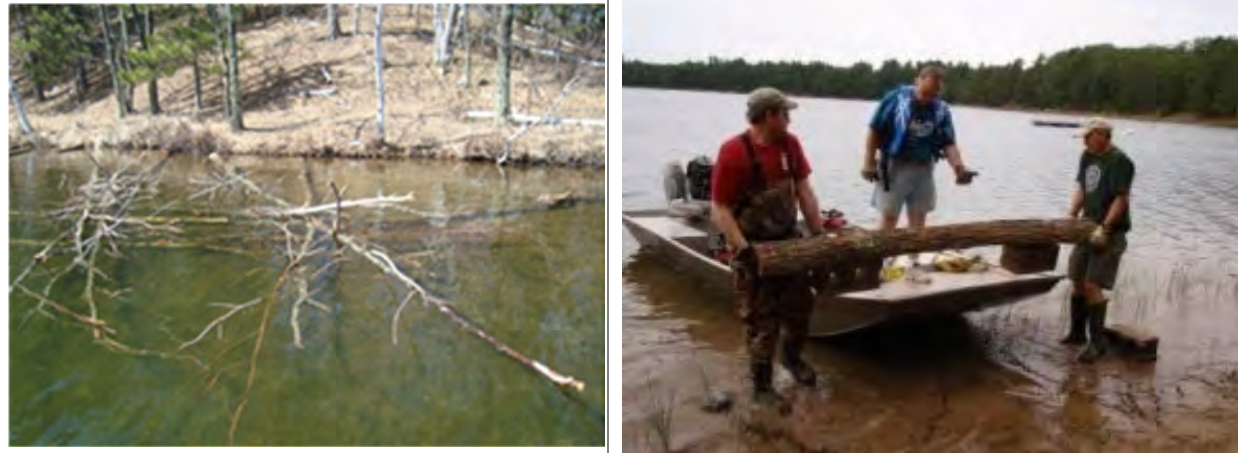
Photograph 8.5.6-3. Examples of fish sticks (left) and half-log habitat structures. (Photos by WDNR)

Some fisheries managers may look to incorporate fish habitat structures on the lakebed or littoral areas extending to shore for the purpose of improving fish habitats. These projects are typically conducted on lakes lacking significant coarse woody habitat in the shoreland zone. The "Fish sticks" program, outlined in the WDNR best practices manual, adds trees to the shoreland zone restoring fish habitat to critical near shore areas. Typically, every site has 3 – 5 trees which are partially or fully submerged in the water and anchored to shore (Photograph 8.5.6-3). The WDNR recommends placement of the fish sticks during the winter on ice when possible to prevent adverse impacts on fish spawning or egg incubation periods. The program requires a WDNR permit and can be funded through many different sources including the WDNR, County Land & Water Conservation Departments or partner contributions.

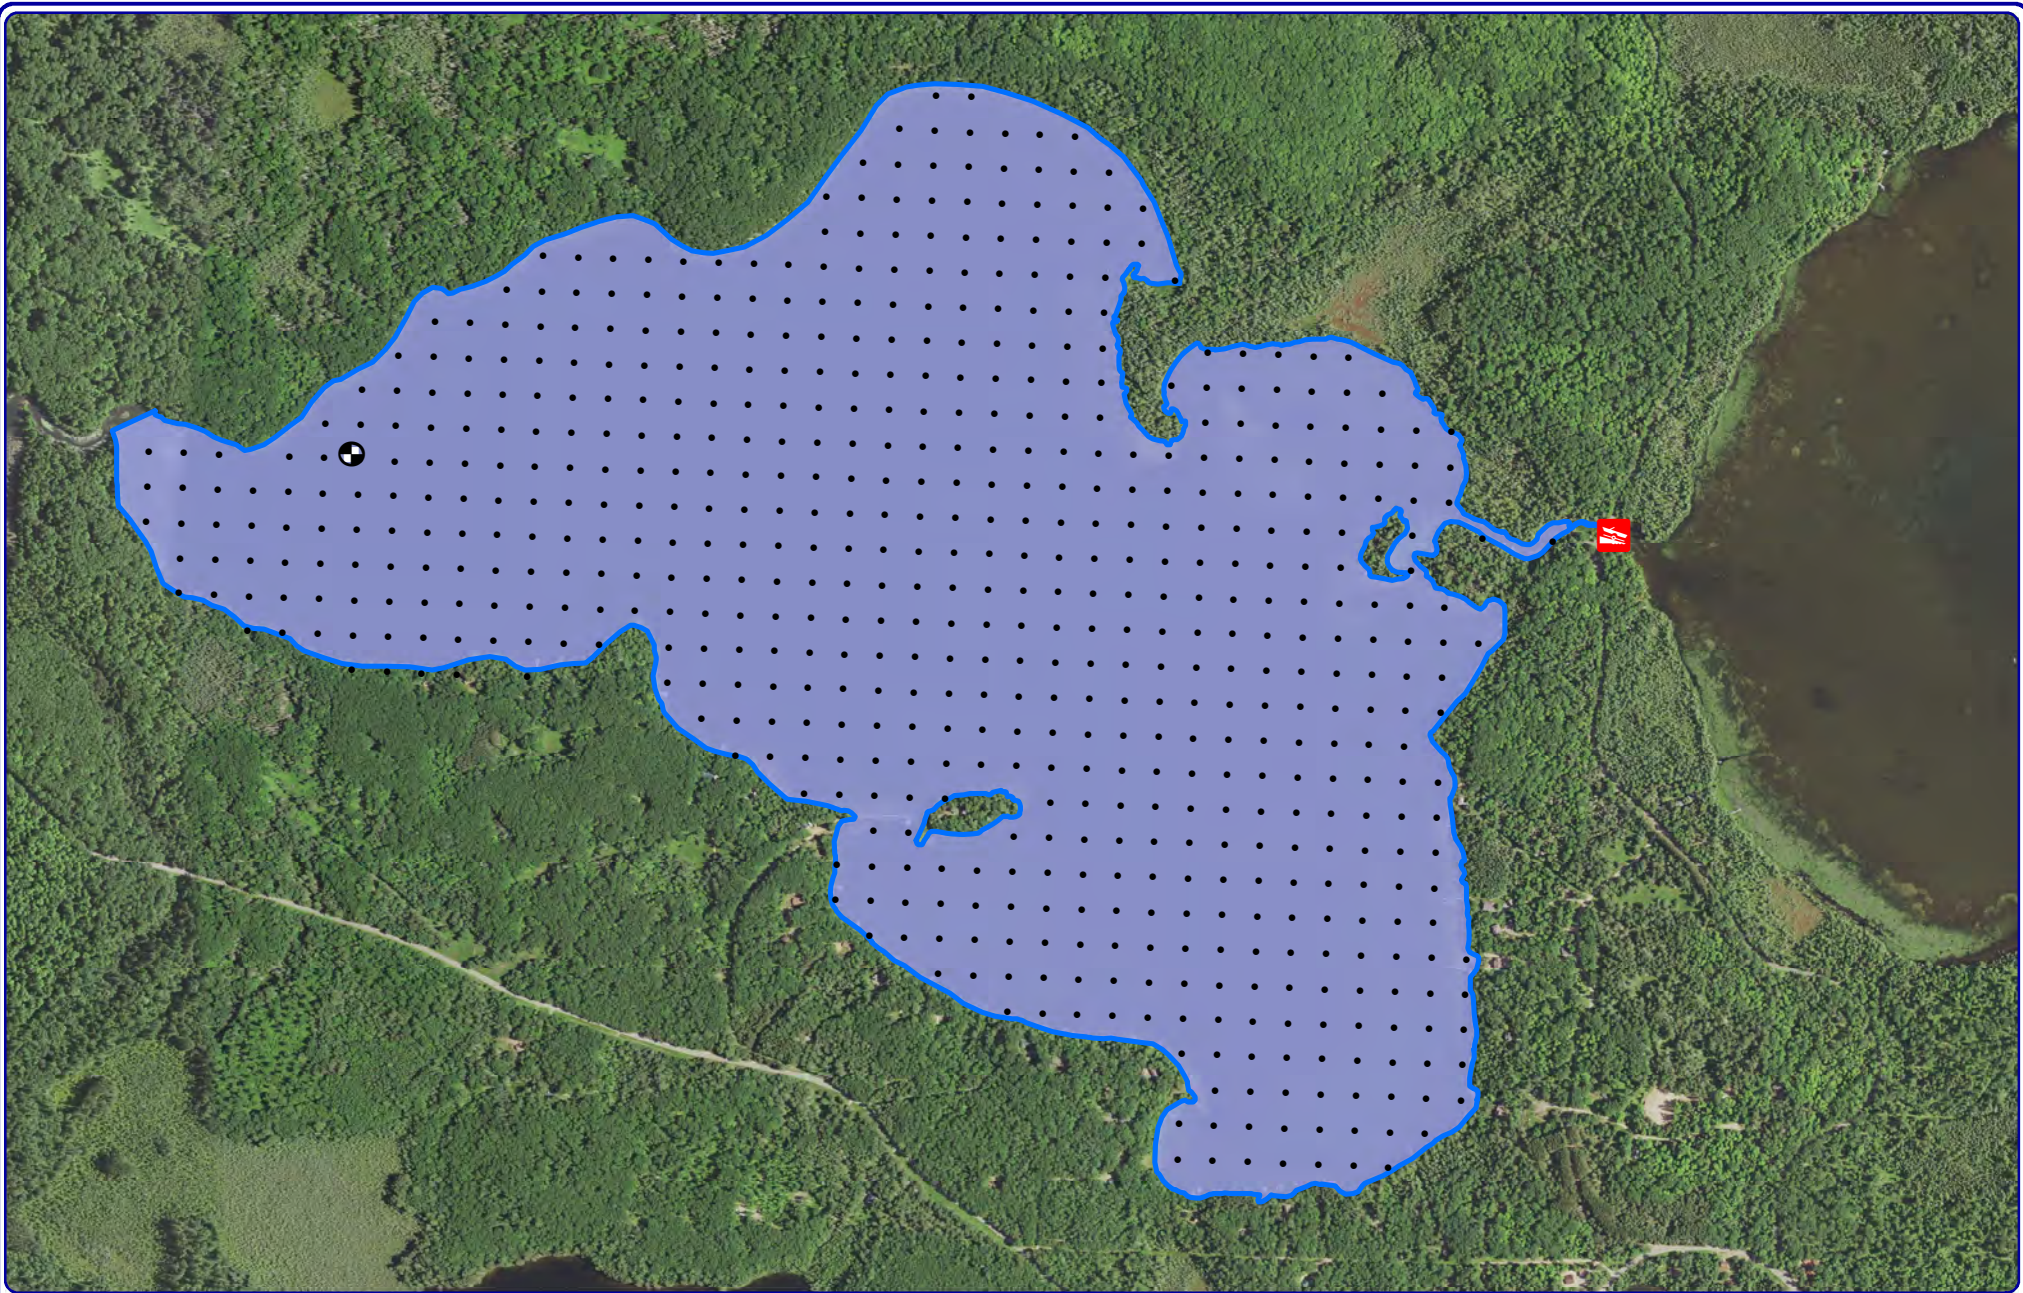
Ballard Lake - Map 1
Town of Plum Lake
 Vilas County, Wisconsin

Ballard Lake, Vilas County, is a 511-acre shallow headwater, mesotrophic drainage lake with a maximum depth of 25 feet and a mean depth of 11 feet (Ballard Lake – Map 1). Its watershed encompasses approximately 2,339 acres within the Manitowish River Watershed and is comprised mainly of intact forests and wetlands. Ballard Lake receives water from the east from Irving Lake and flows west into White Birch Lake. In 2018, 40 native aquatic plant species were located within the lake, of which Fern-leaf pondweed (*Potamogeton robbinsii*) was the most common. Two NHI-listed species were found in Ballard Lake: Vasey’s pondweed (*Potamogeton vaseyi*) and Northeastern bladderwort (*Utricularia resupinata*).

Project Location & Lake Boundaries

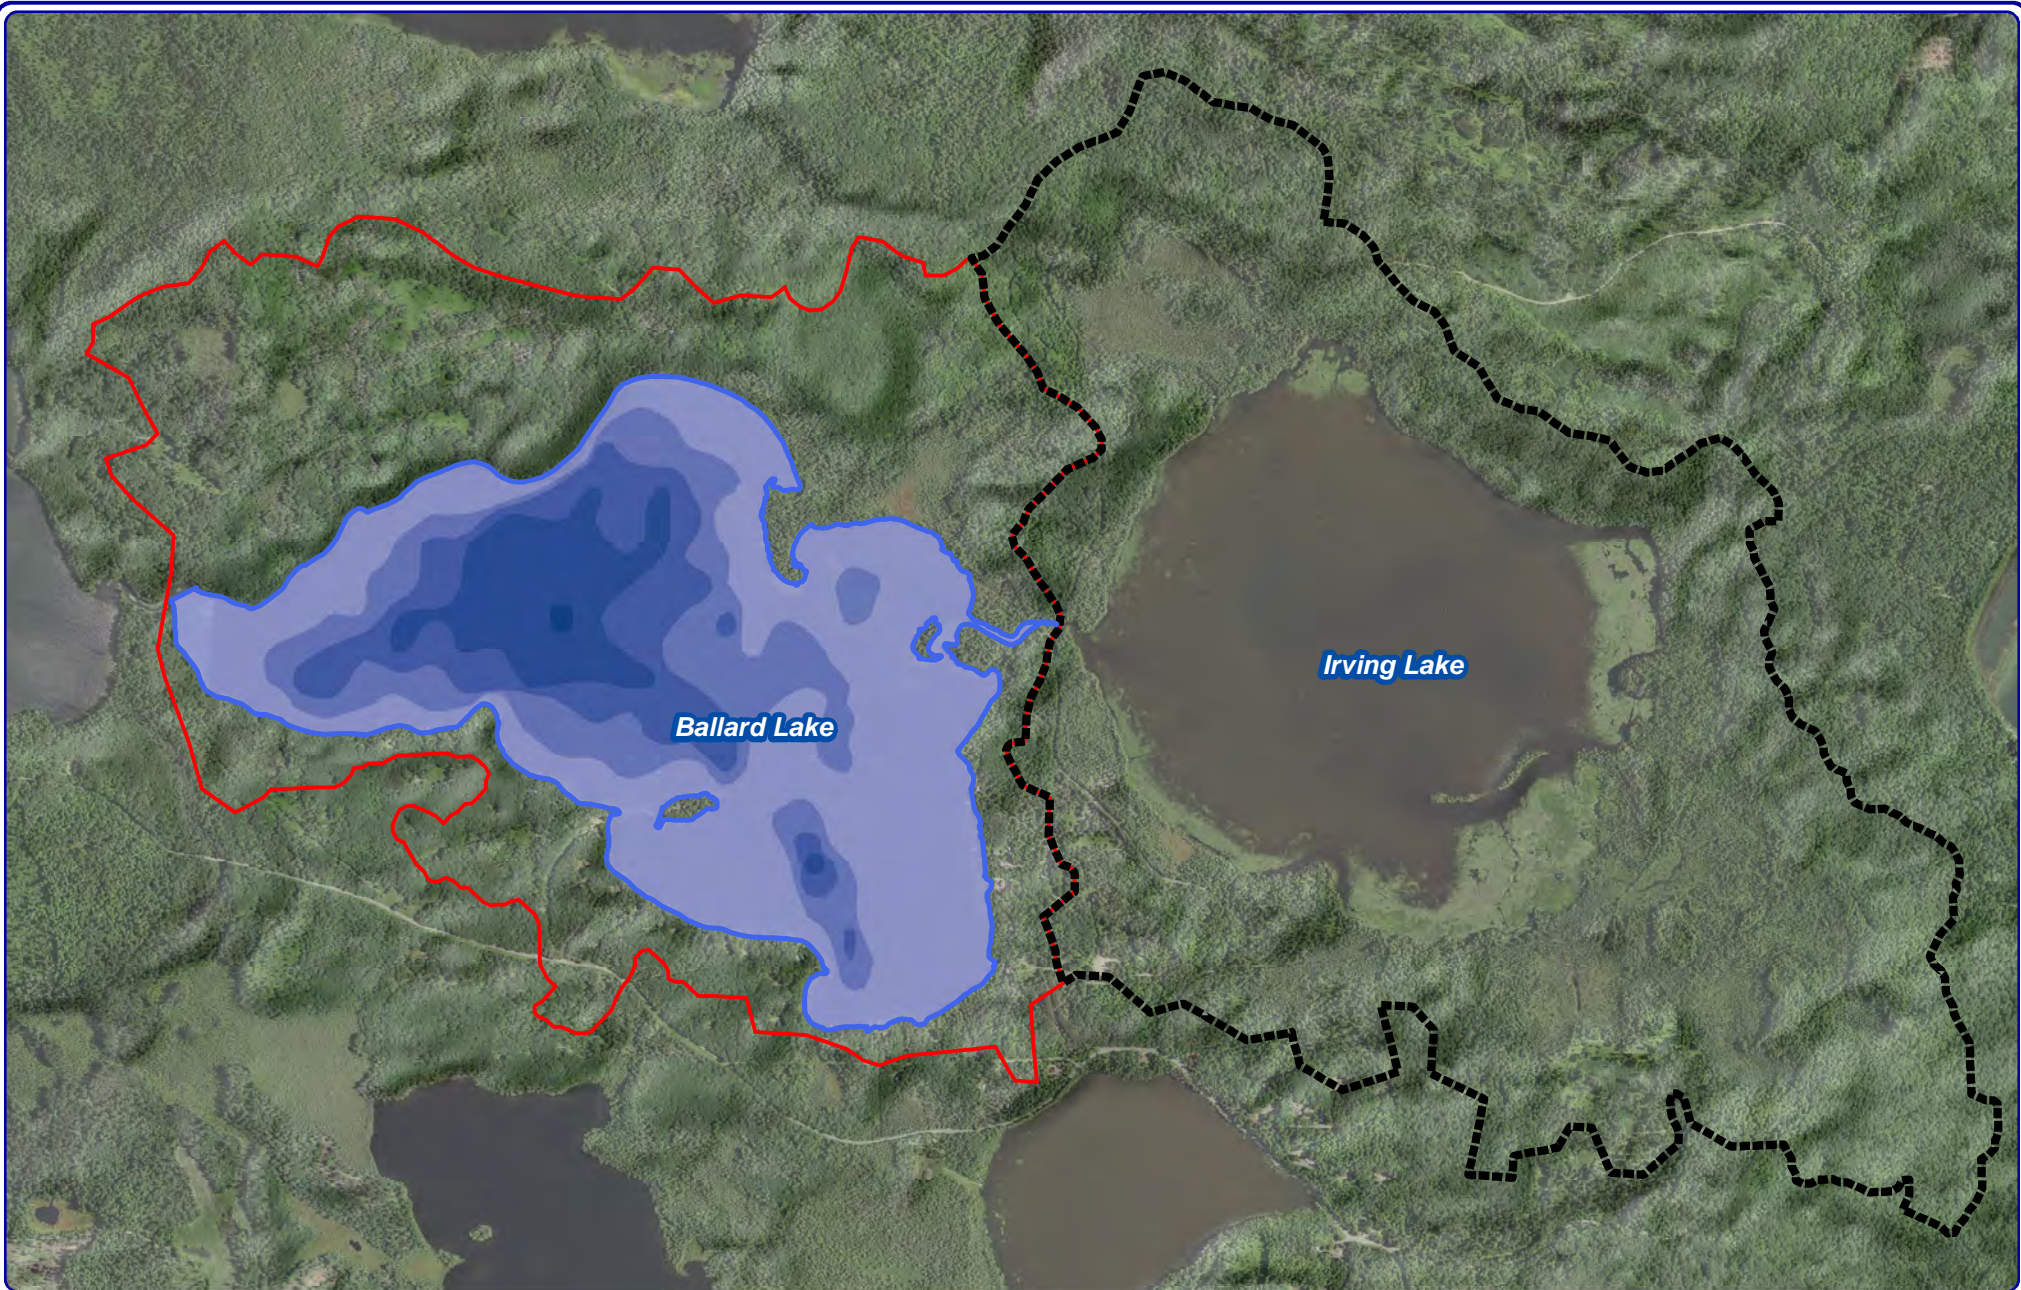
Town of Plum Lake
 Vilas County, Wisconsin

**Watershed Boundaries
 & Land Cover Types**
