8.5 Ballard Lake

An Introduction to Ballard Lake

8.5.1 Ballard Lake Water Quality

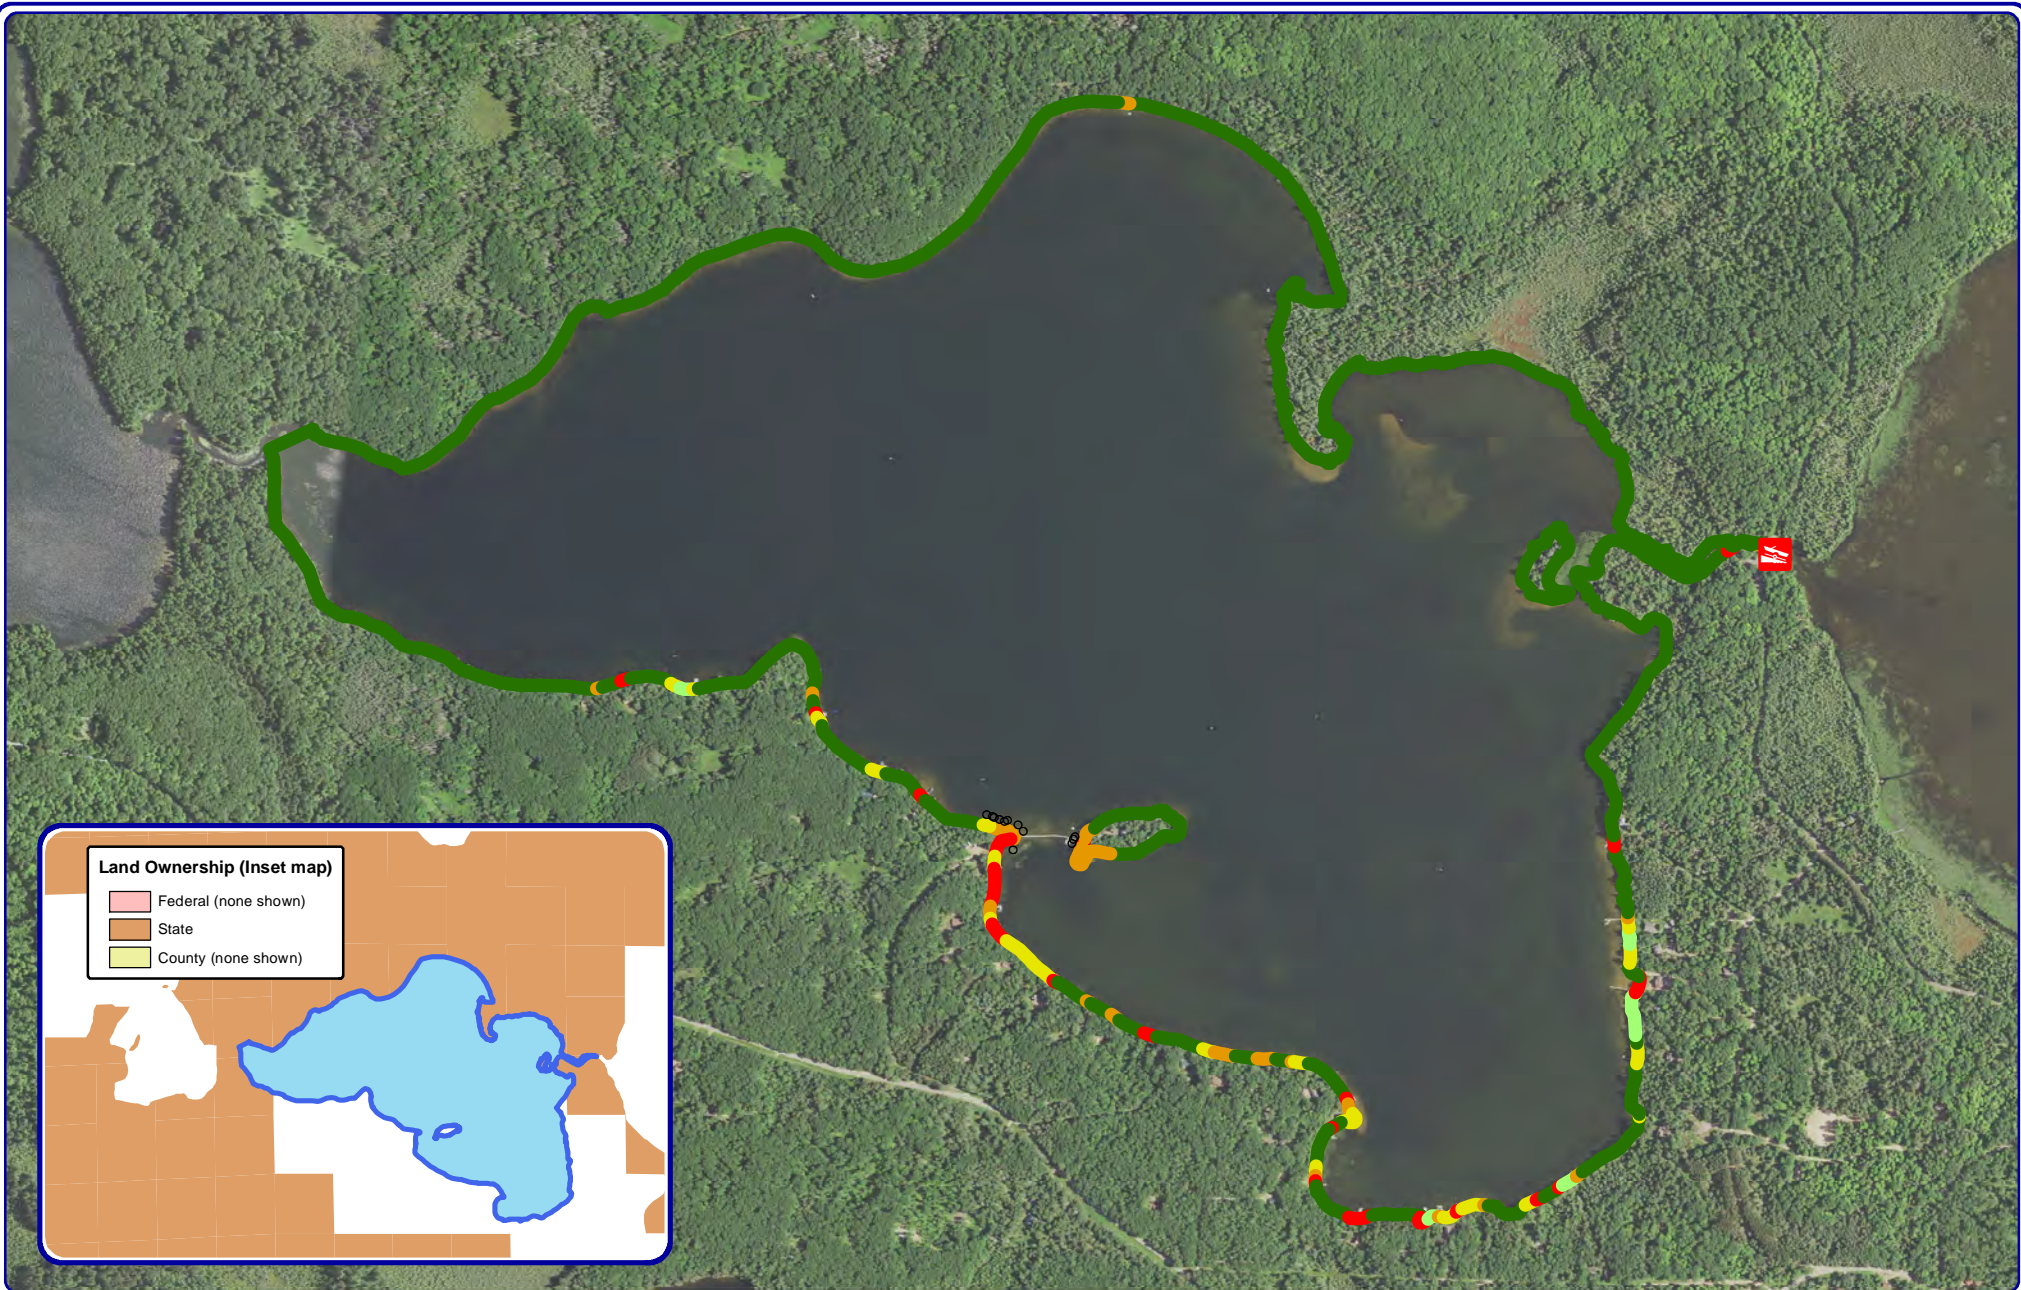
Town of Plum Lake
 Vilas County, Wisconsin

As mentioned previously in the Town-wide Shoreland Condition Section, one of the most sensitive areas of the watershed is the immediate shoreland area. This area of land is the last source of protection for a lake against surface water runoff, and is also a critical area for wildlife habitat. In the fall of 2018, Ballard Lake's immediate shoreline was assessed in terms of its development. Ballard Lake has stretches of shoreland that fit all of the five shoreland assessment categories. In all, 5.1 miles of natural/undeveloped and developed-natural shorelines were observed during the survey (Figure 8.5.3-1). This constitutes about 86% of Ballard Lake's shoreline. These shoreland types provide the most benefit to the lake and should be left in their natural state if at all possible. During the survey, 0.6 miles of urbanized and developed-unnatural shoreline (10%) was observed. If restoration of the Ballard Lake shoreline is to occur, primary focus should be placed on these shoreland areas as they currently provide little benefit to, and actually may harm, the lake ecosystem. Ballard Lake - Map 3 displays the location of these shoreline lengths around the entire lake.

Shoreland Condition Assessment

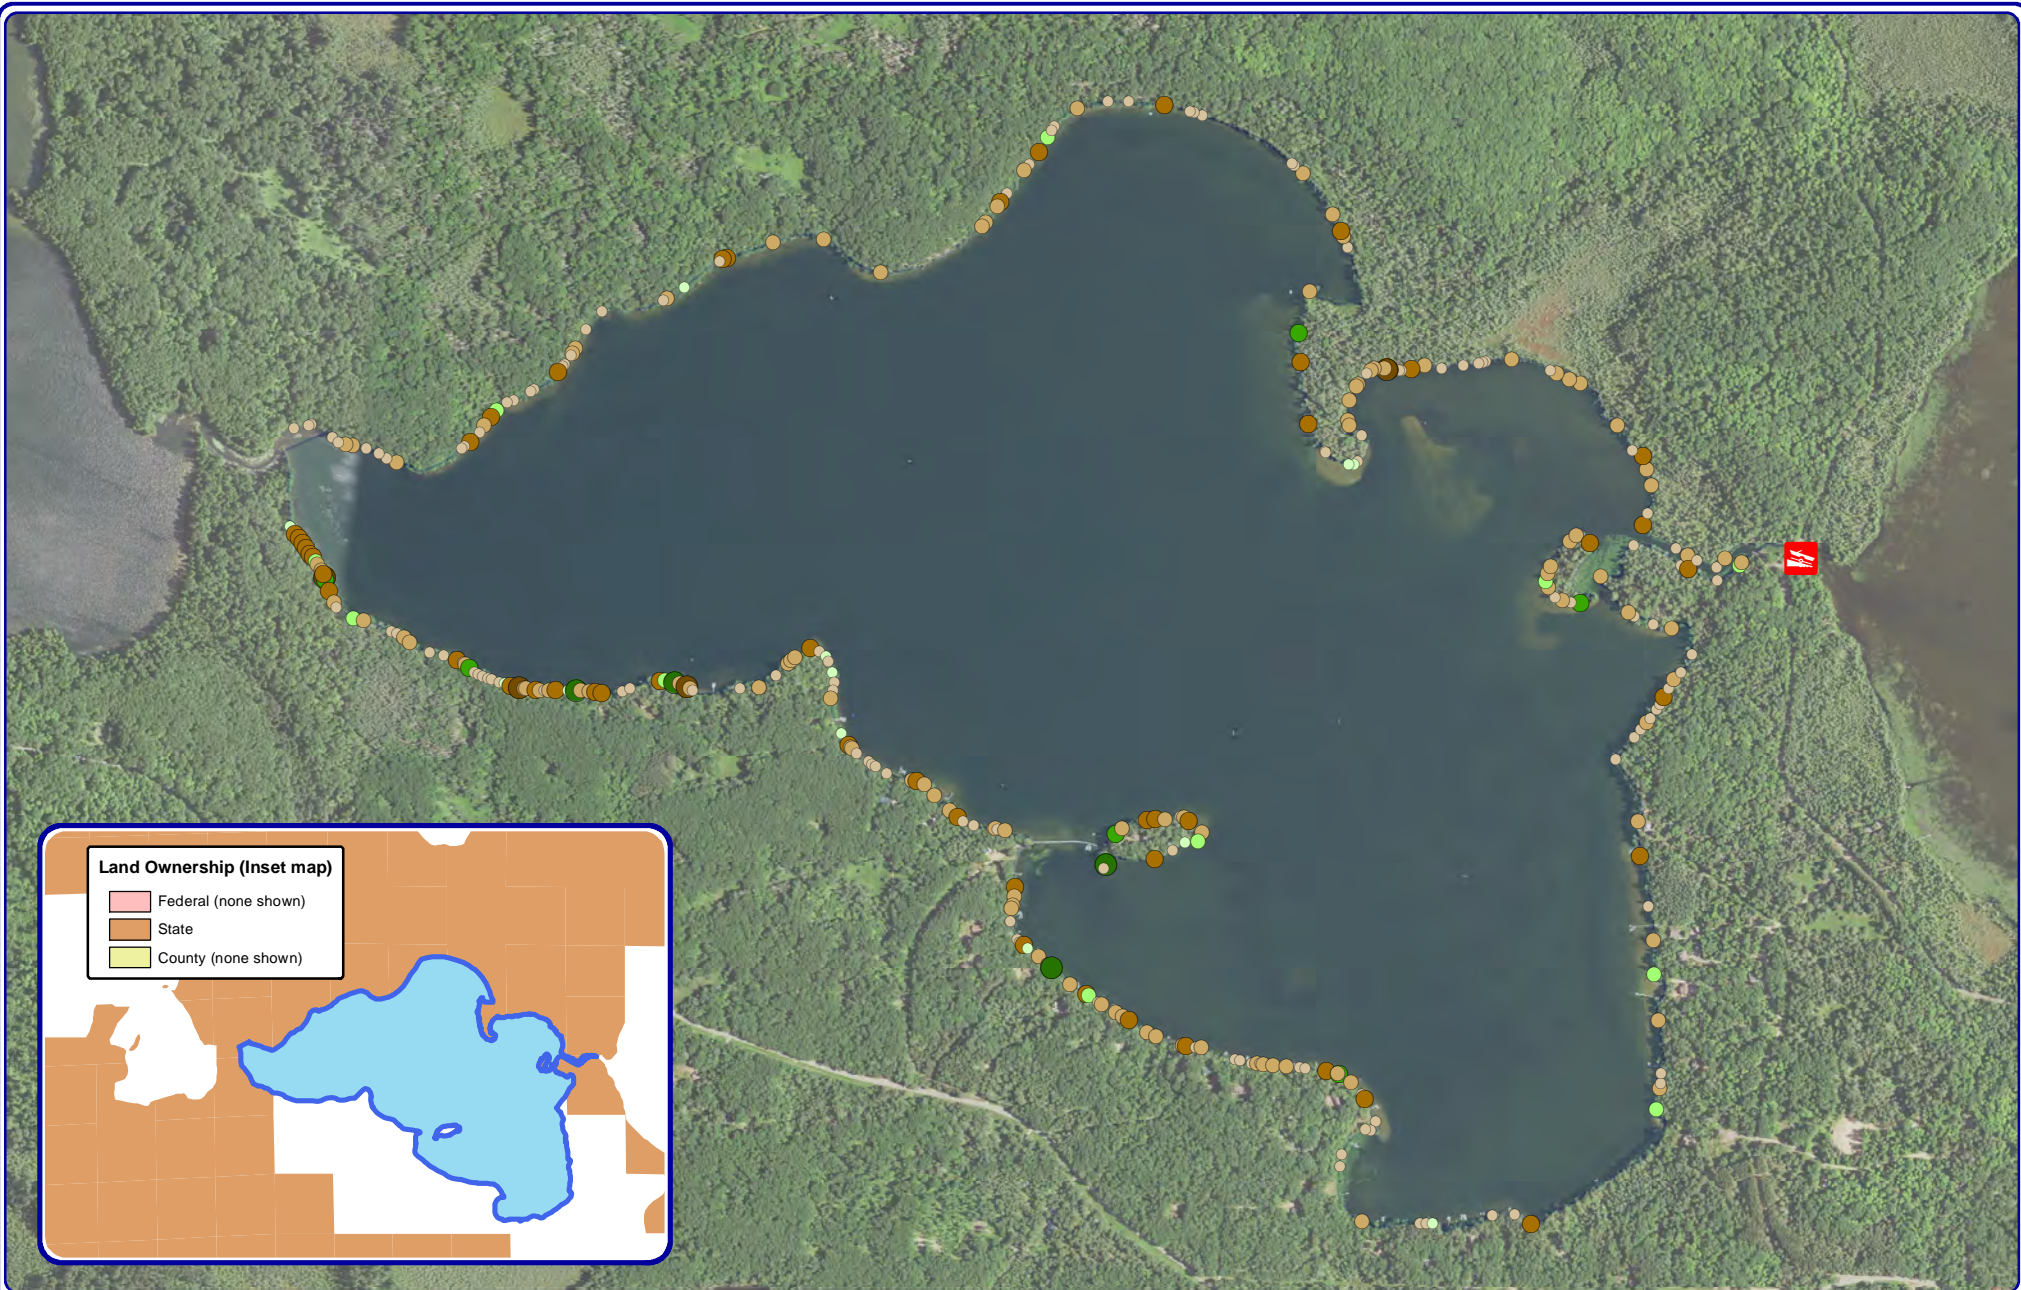
Ballard Lake - Map 4
 Town of Plum Lake
 Vilas County, Wisconsin
**Coarse Woody
 Habitat**

During this survey, 333 total pieces of coarse woody habitat were observed along 5.9 miles of shoreline (Ballard Lake - Map 4), which gives Ballard Lake a coarse woody habitat to shoreline mile ratio of 57:1 (Figure 8.5.3-2). Only instances where emergent coarse woody habitat extended from shore into the water were recorded during the survey. Of the 333 total pieces of coarse woody habitat observed during the survey, 298 pieces were 2-8 inches in diameters, 35 were 8 inches in diameter or greater, and no clusters of pieces of coarse woody habitat were found.

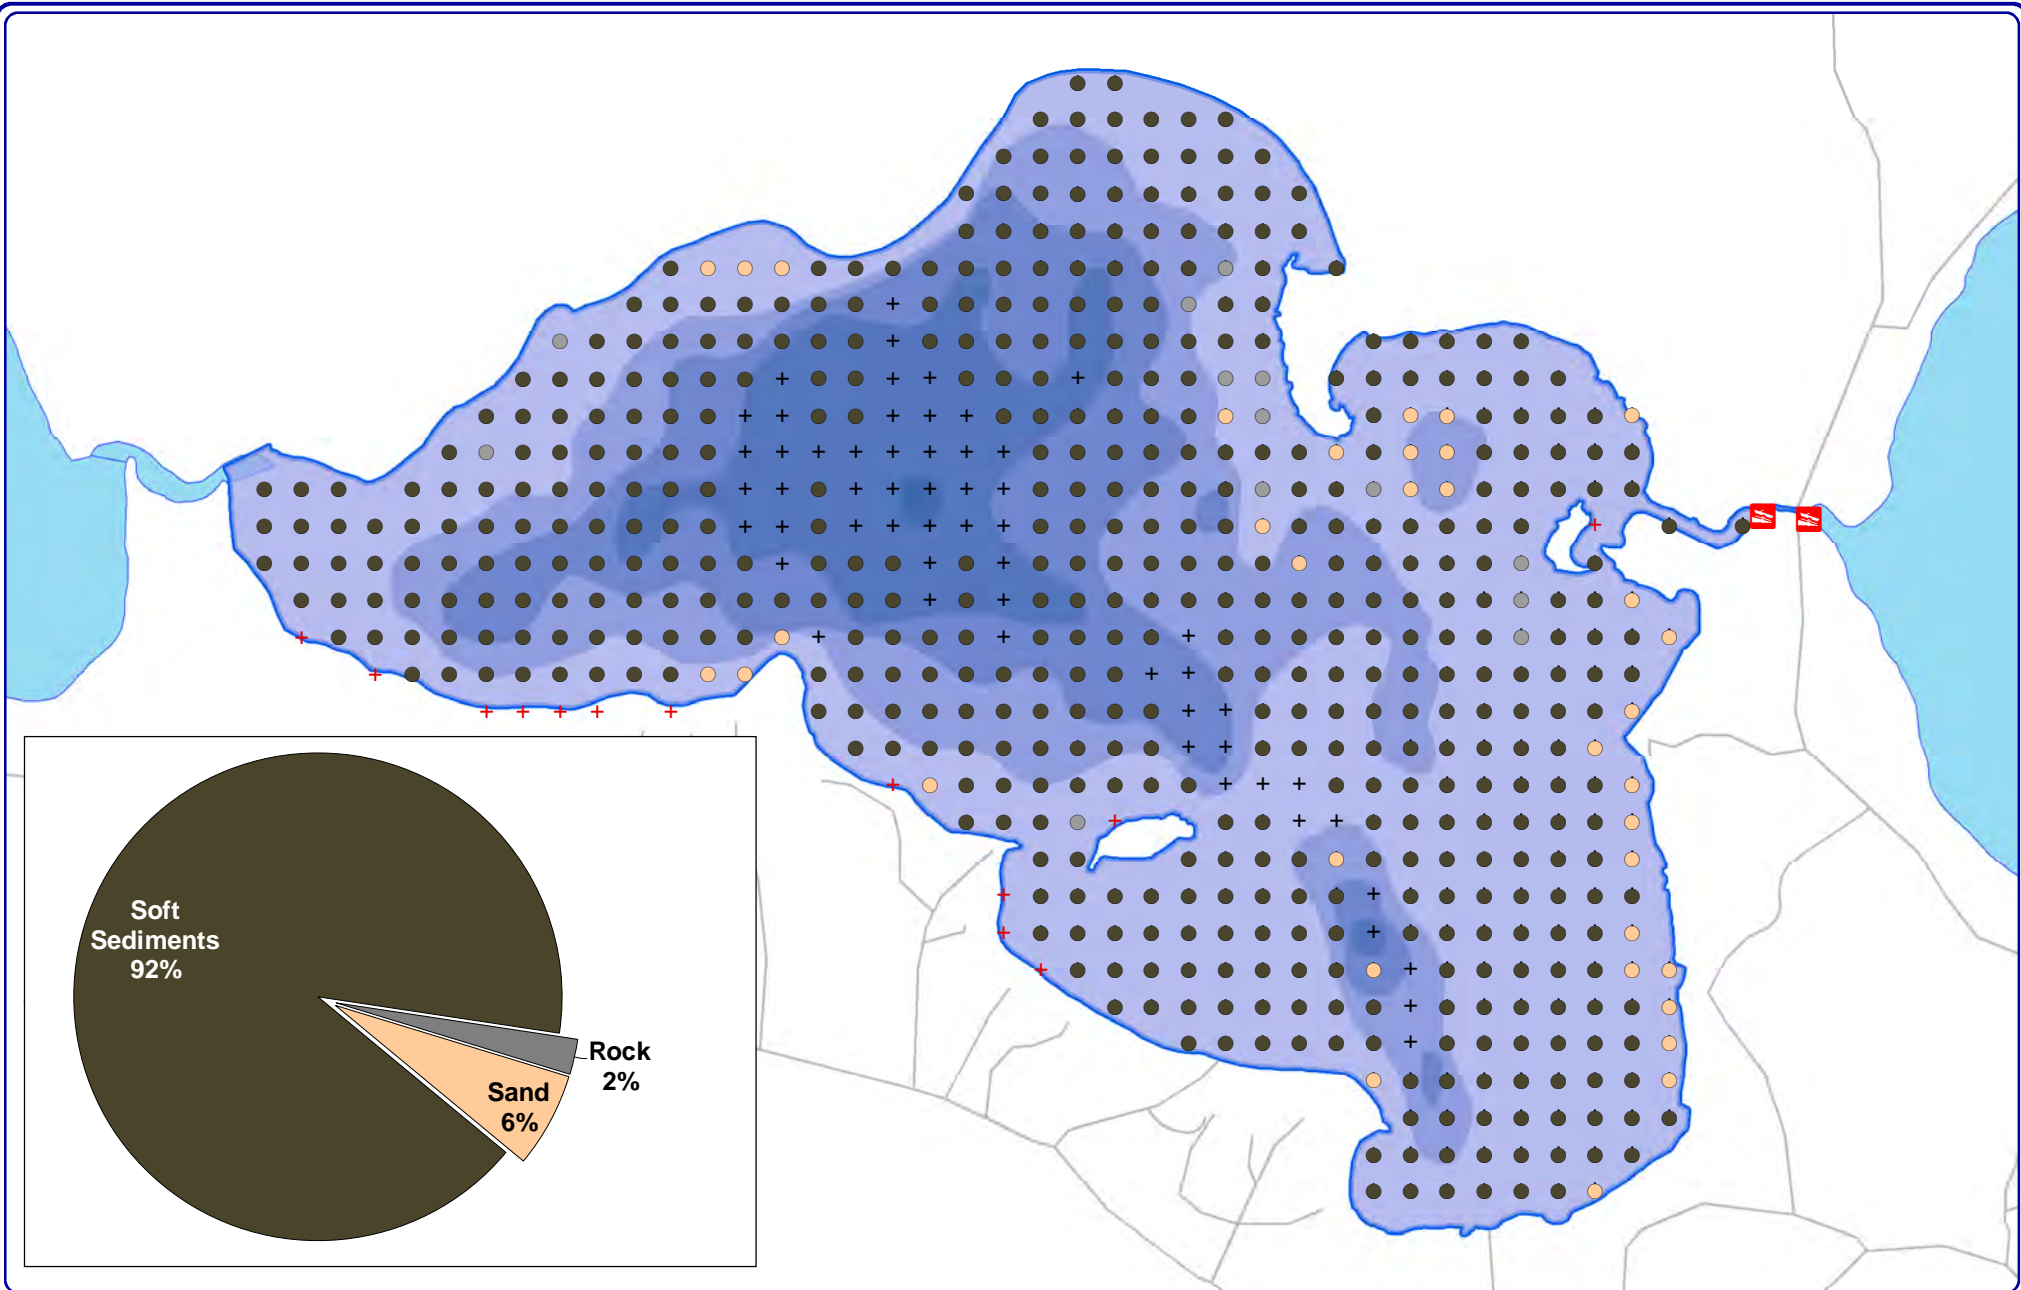
Ballard Lake- Map 5
Town of Plum Lake
Vilas County, Wisconsin

As discussed in the primer section, sediment data were collected at each sampling location within the littoral zone during the point-intercept survey. Approximately 92% of the point-intercept locations within littoral areas contained fine, organic sediments (muck), 6% contained sand, and 2% contained rock (Figure 8.5.4-1). The shallow areas on the eastern shoreline of Ballard Lake contained more sand than any other areas around the lake (Ballard Lake - Map). Like terrestrial plants, different aquatic plant species are adapted to grow in certain substrate types; some species are only found growing in mucky substrates, others only in sandy areas, and some can be found growing in either. Lakes that have varying substrate types generally support a higher number of plant species because of the different habitat types that are available.

Soft
Sediments
92%

Sand
6%

**2018 PI Survey:
Substrate Types**

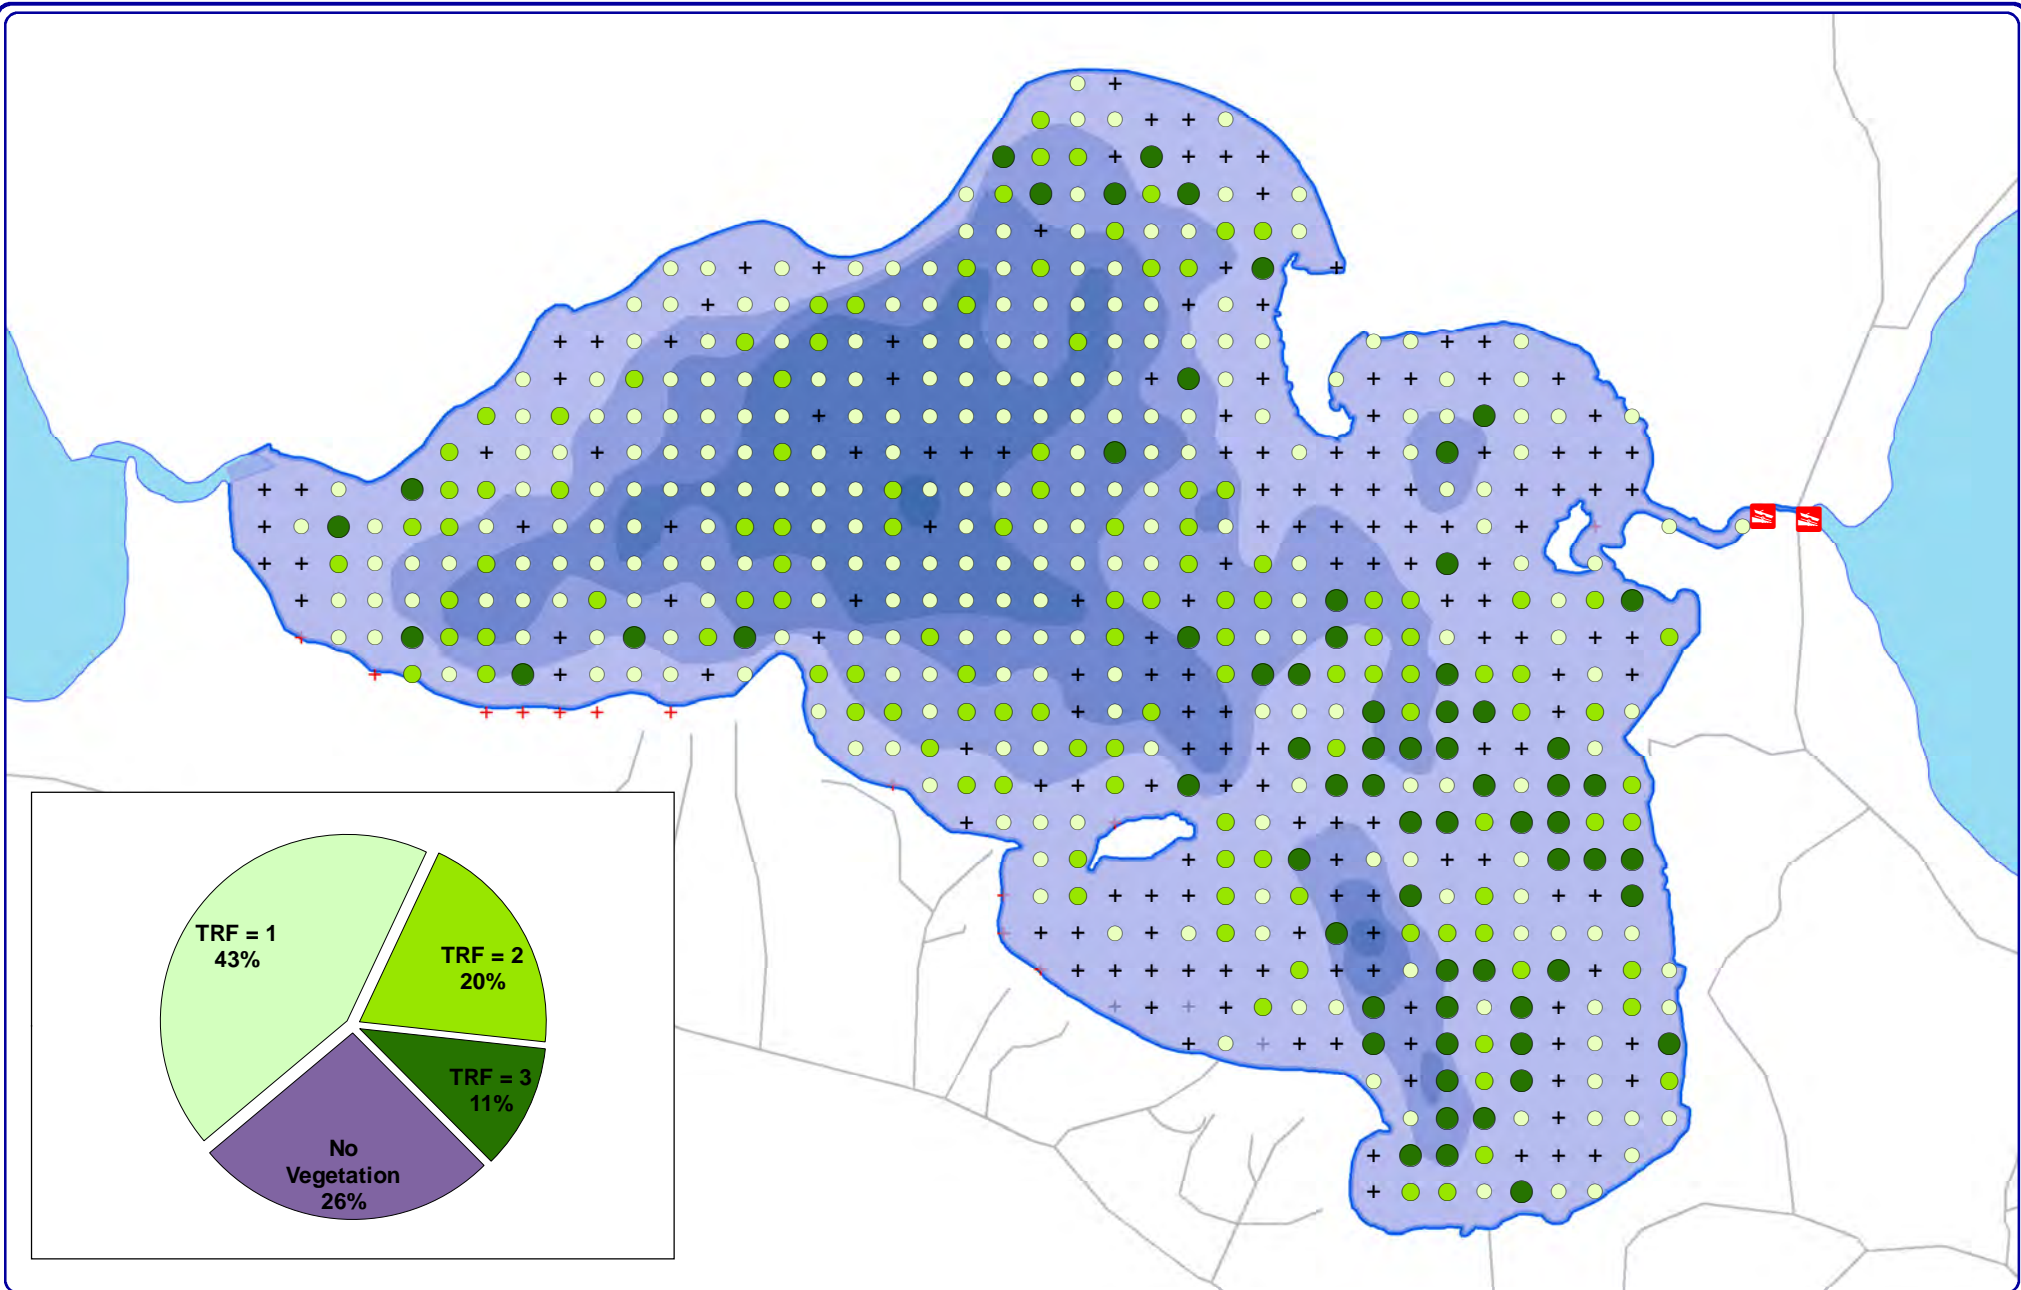
Ballard Lake - Map 6
 Town of Plum Lake
 Vilas County, Wisconsin

Of the 608 point-intercept sampling locations that fell at or below the maximum depth of plant growth in 2018, approximately 74% contained aquatic vegetation. Ballard Lake – Map 6 displays the point-intercept locations that contained aquatic vegetation in 2018, and the total rake fullness ratings at those locations. Forty-three percent of the point-intercept locations had a total rake fullness (TRF) rating of 1, 20% had a total rake fullness rating of 2, and 11% had the highest total rake fullness rating of 3 (Figure 8.5.4-2). Twenty-six percent of the littoral zone had no vegetation.

**2018 PI Survey: Aquatic
 Vegetation Distribution**

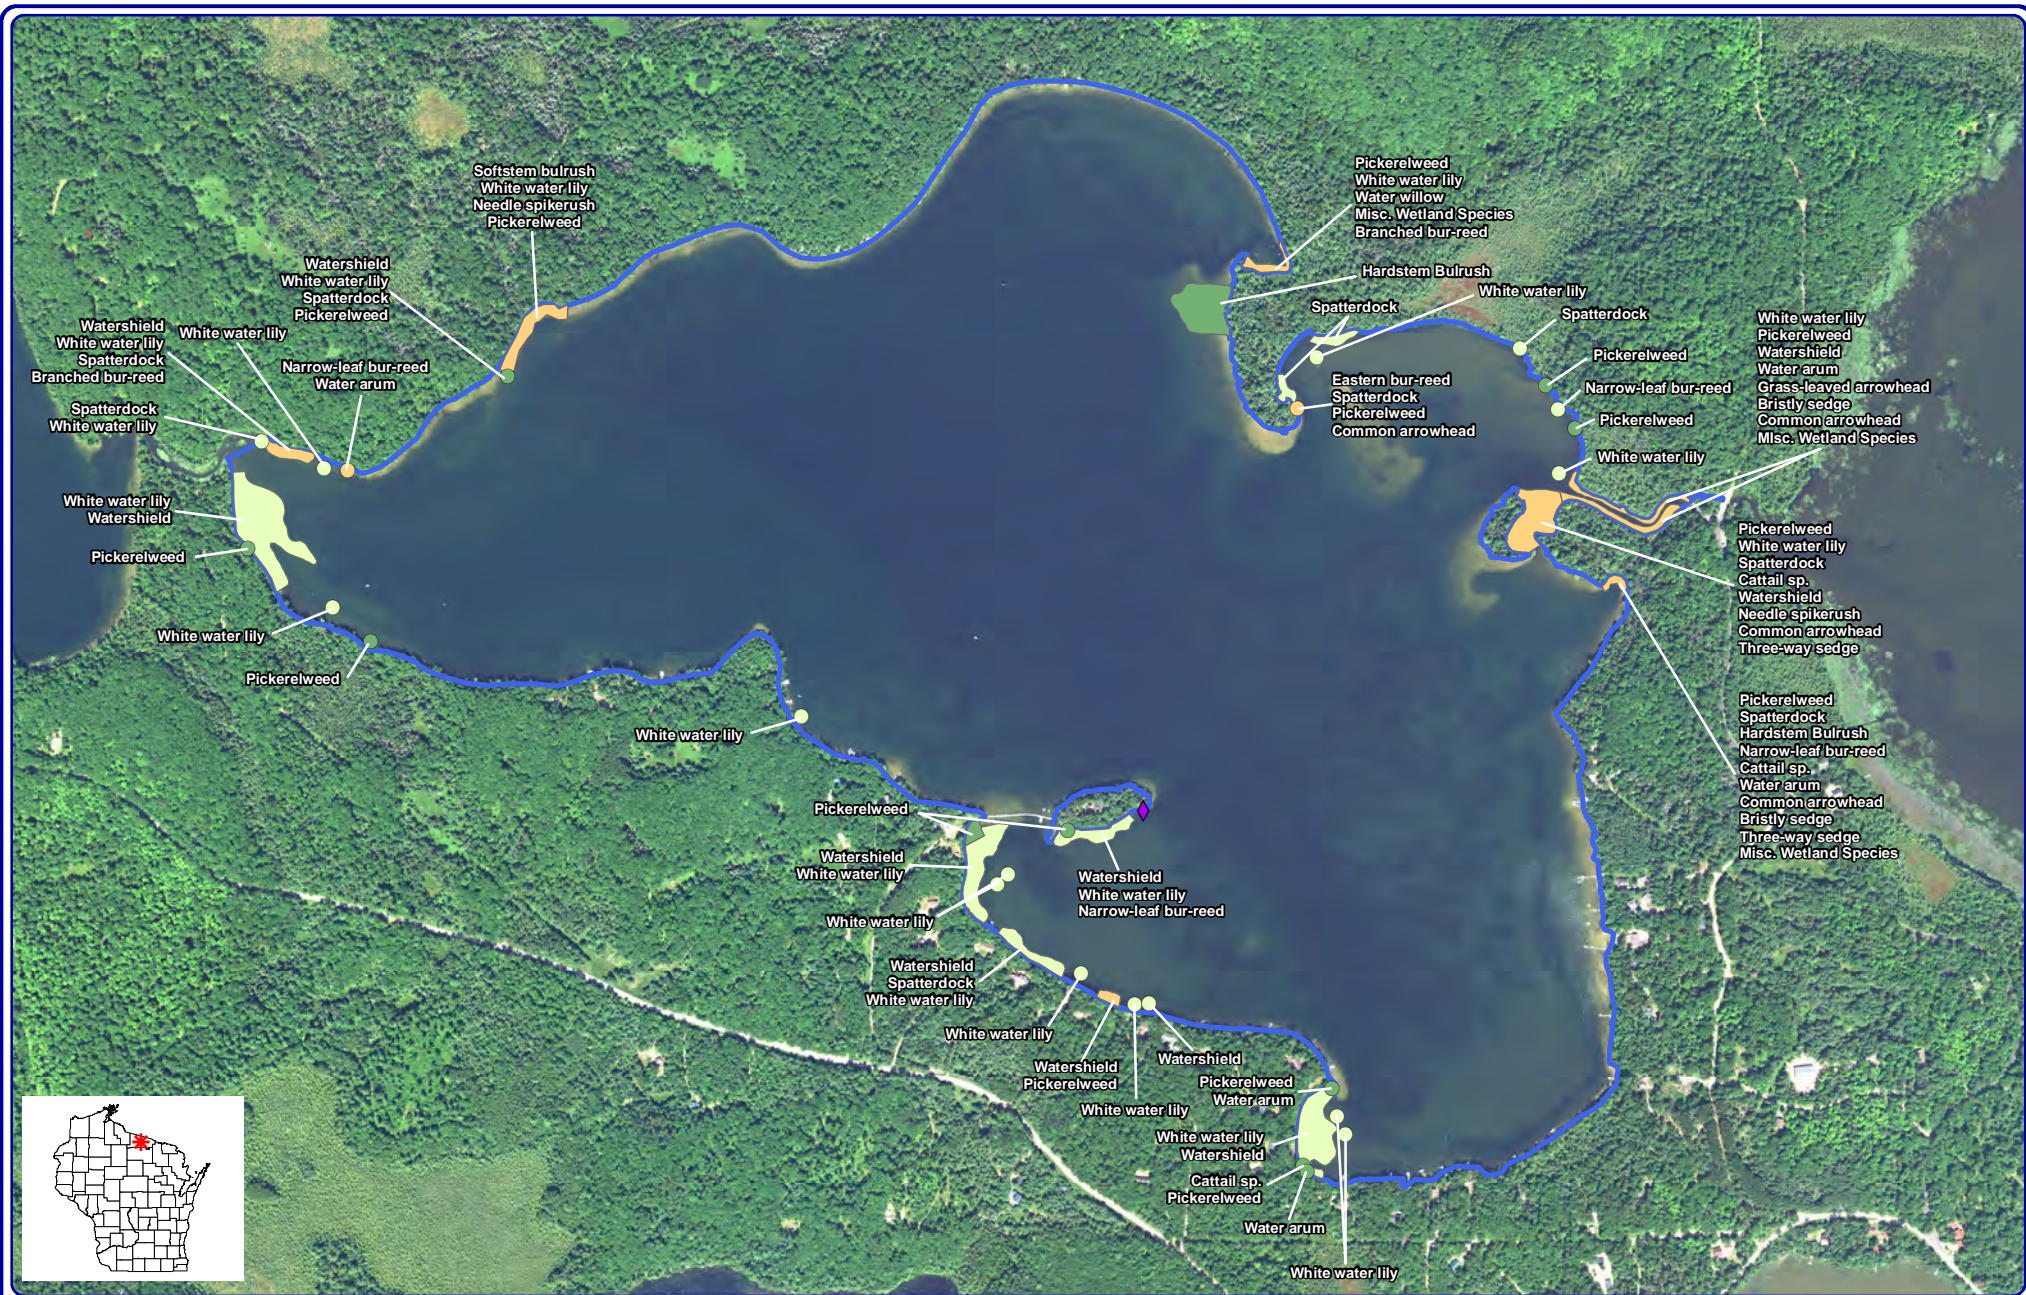
In 2018, Onterra ecologists also conducted a survey aimed at mapping emergent and floating-leaf aquatic plant communities in Ballard Lake. This survey revealed Ballard Lake contains just under 13 acres of these communities comprised of 14 different aquatic plant species (Ballard Lake – Map 7 and Table 8.5.4-2). These native emergent and floating-leaf plant communities provide valuable fish and wildlife habitat that is important to the ecosystem of the lake. These areas are particularly important during times of fluctuating water levels, since structural habitat of fallen trees and other forms of coarse-woody habitat can be quite sparse along the shores of receding water lines.
